| Client > | FUELLED | A# > | 495835 | Head Mat. > | SA516-70N | OD > | 72" |
| Report# > | 5361-4 | Ser. # > | 12895 | Head Th. > | .313" | Year > | 2003 |
| Equipment > | KNOCKOUT TANK | MAWP > | 50 PSI | Shell Th. > | .375" | RT > | RT-1 |

# Alpine NDT Services Inc.

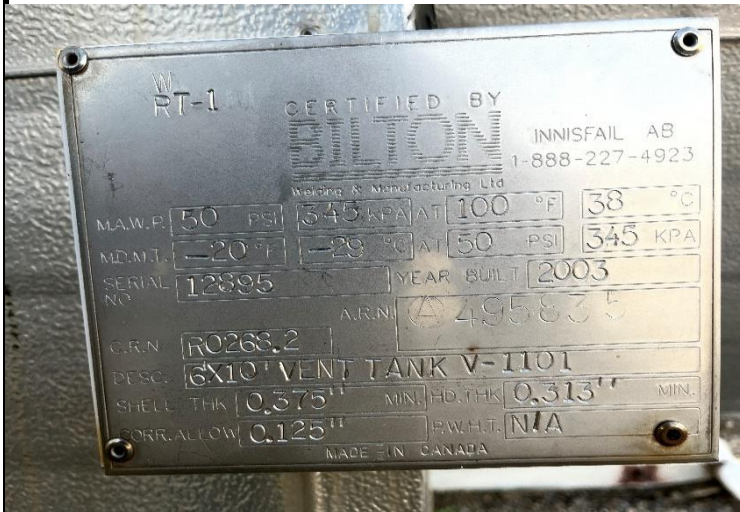
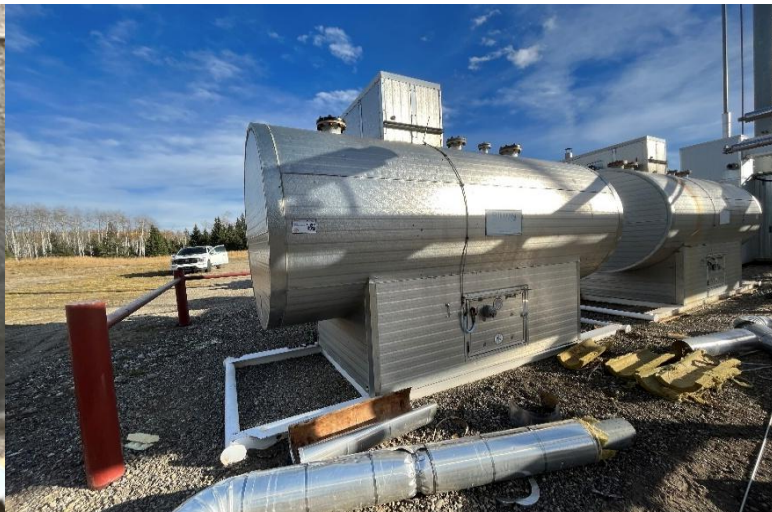
| Component | Disposition | Comments |
|---|---|---|
| Shell | Good | Clean Surface, No Superficial Specs Of Rust, No Pitting |
| Heads | Good | Clean Surface, No Rust, No Pitting (Limited Visual Access) |
| Insulation | Good | No Tears, Small Dents (Assumed to be from hail) |
