PRESSURE VESSEL & COLUMN INSPECTION REPORT

LSD: b-49-C/93-P-2 Date: June 16th 2014 SAP Equipment ID: 66156026

INSPECTION SUMMARY

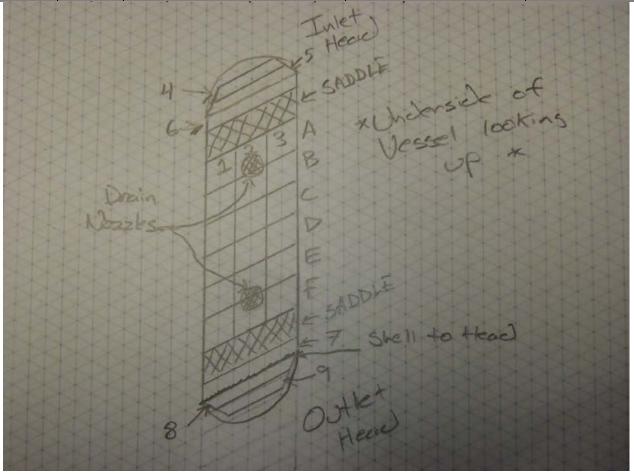
UT THICKNESS READINGS TAKEN ON LOWER SHELL, LOWER HEADS AND INLET NOZZLE ALL READINGS ARE THE LOWEST IN THE AREA SCANNED

AREA	NOM.	1	2	3
LOWER SHELL				
Α	0.375"	0.370"	0.353"	0.355"
В	0.375"	0.356"	0.342"	0.348"
С	0.375"	0.355"	0.338"	0.360"
D	0.375"	0.362"	0.365"	0.361"
E	0.375"	0.371"	0.363"	0.361"
F	0.375"	0.372"	0.362"	0.359"
INLET HEAD				
4	0.313	0.344"		
5	0.313	0.335"		
6	6 0.375" 0.336"		Shell side of Shell-Head butt weld	
OUTLET HEAD				
7	0.375"	0.359"	Shell side of Shell-Head butt weld	
8	0.313	0.300"		
9	0.313	0.360"		
INLET NOZZLE				
4" XH	0.337"	0.311"
