S/N: 028328-4 T-104

Location: 15-10-51-24W3M

Type of Inspection: UT/vis	Rev: N/A	Client: HUSKY OIL OPERATIONS	Date: 2020-Aug-07
Test Technique: o-deg/ Floor Scan		IRISNDT #: LYN2000727	WO #: US-062179-00-01-T1
Equipment: DMS2 /Flashlight/ MK 4 Floor scanner		Location: 15-10-51-24W3M	PO #: 8401417768
Code/Standard: Client Information		Item Inspected: T-103 Production tank	Appr# 2Z-10005709

A Visual examination UT thickness and MFL floor scan was carried out on the following 1000 Bbl tank for the purpose of determining tank condition and inspection interval. See attached pages for MFE results, UT thickness readings and observations.

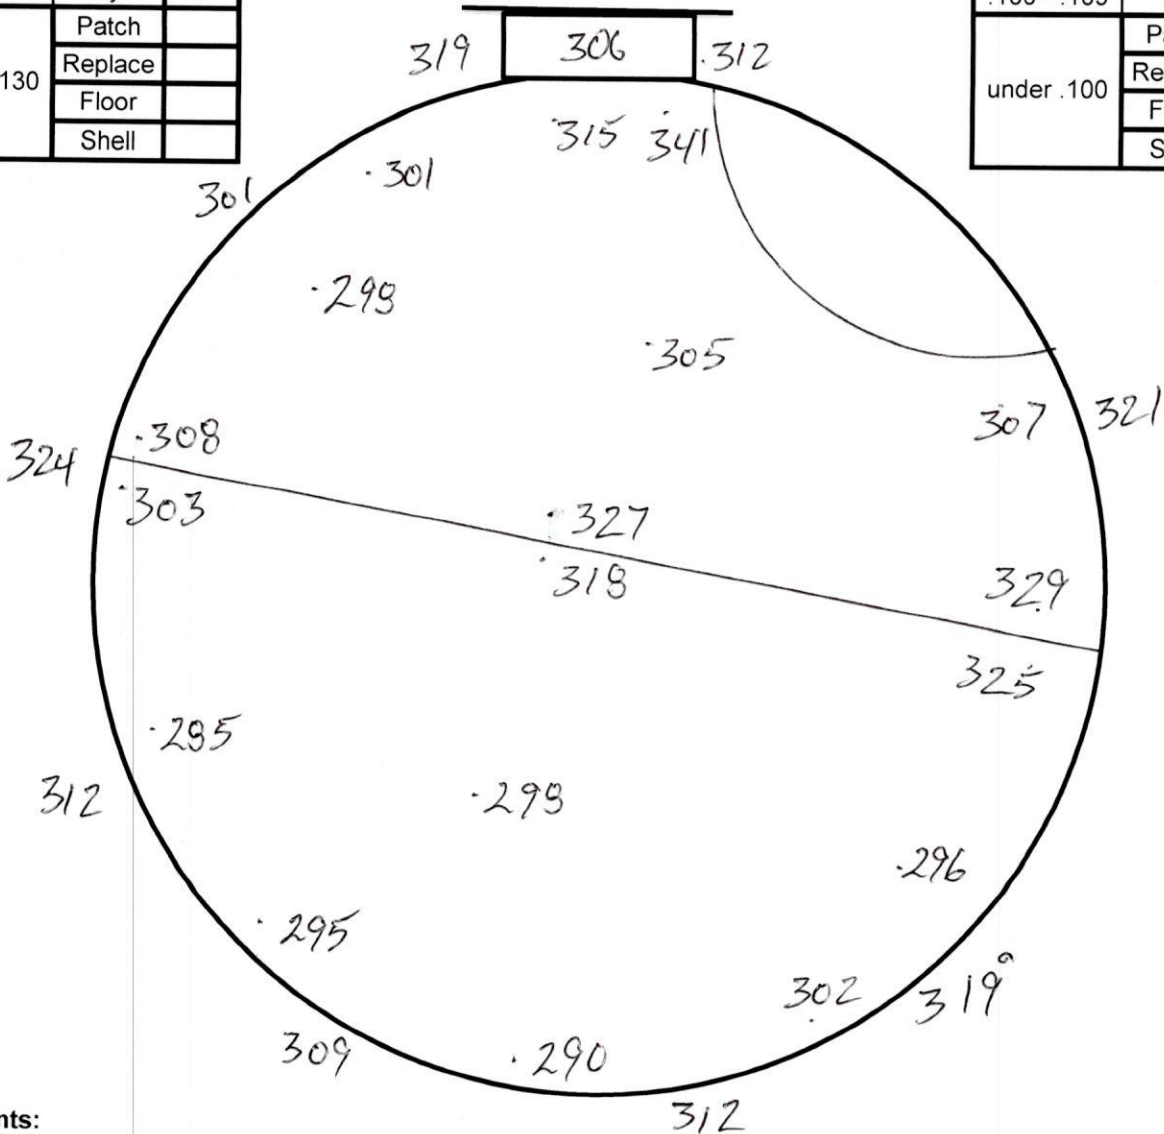
With MFE		
.140 - .150	5 yr	<input checked="" type="checkbox"/>
.130 - .139	4 yr	
.120 - .129	3 yr	
.110 - .119	2 yr	
.100 - .109	1 yr	
under .100	Patch	
	Replace	
	Floor	
	Shell

4-areas of Internal coating on the shell require patching
 Recommend stripping insulation from the top of the fire tube burner, Manway, Vault to prevent UIC
 Recommend stripping bottom 2" of Insulation and painting black to prevent UIC
