S/N: 028328-2 T-102

Type of Inspection: UT/Vis	Rev: N/A	Client: HUSKY OIL OPERATIONS	Date: 2020-Aug-07
Test Technique: o-deg/ Floor Scan		IRISNDT #: LYN2000727	WO #: US-062179-00-01-TI
Equipment: DMS2 /Flashlight/ MK 4 Floor scanner		Location: 15-10-51-24W3M	PO #: 8401417768
Code/Standard: Client Information		Item Inspected: T-102 Sales tank	Appr# 2Z-10005709

A Visual examination UT thickness and MFL floor scan was carried out on the following 1000 Bbl tank for the purpose of determining tank condition and inspection interval. See attached pages for MFE results, UT thickness readings and observations.

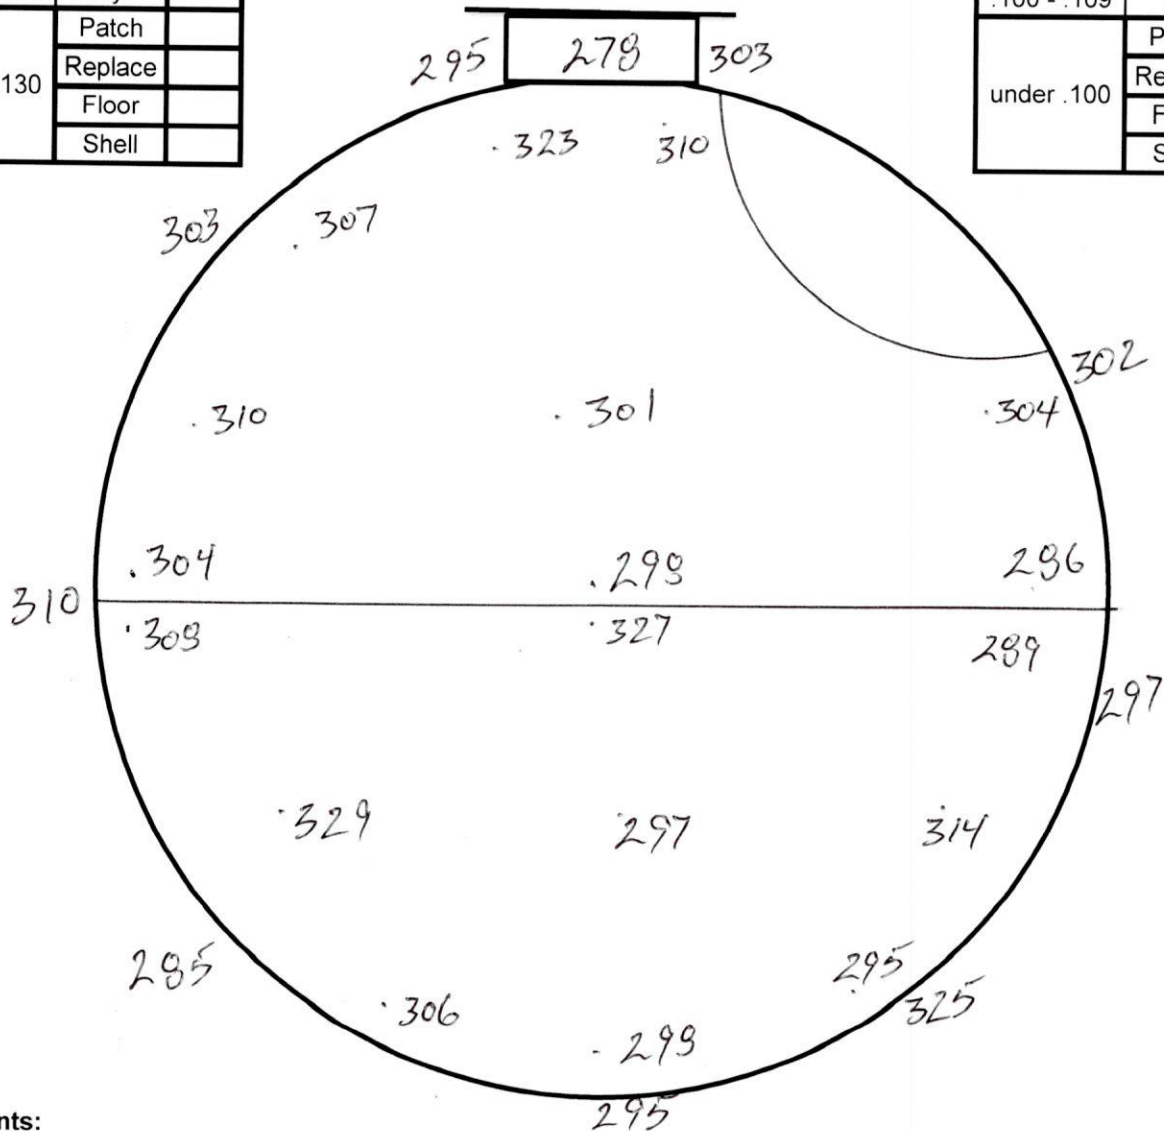
9-areas of Internal coating on the shell require patching

Recommend stripping insulation from the top of the fire tube burner, Manway, Vault to prevent UIC

Recommend stripping bottom 2" of Insulation and painting black to prevent UIC
