Tank Type: Production

S/N: 028328-3 T-103

CAP: 1000 bbl

Type of Inspection: UT/Vis	Rev: N/A	Client: HUSKY OIL OPERATIONS	Date: 2020-Aug-07
Test Technique: o-deg/ Floor Scan		IRISNDT #: LYN2000727	WO #: US-062179-00-01-T1
Equipment: DMS2 /Flashlight/ MK 4 Floor scanner		Location: 15-10-51-24W3M	PO #: 8401417768
Code/Standard: Client Information		Item Inspected: T-103 Production tank	Appr# 2Z-10005709

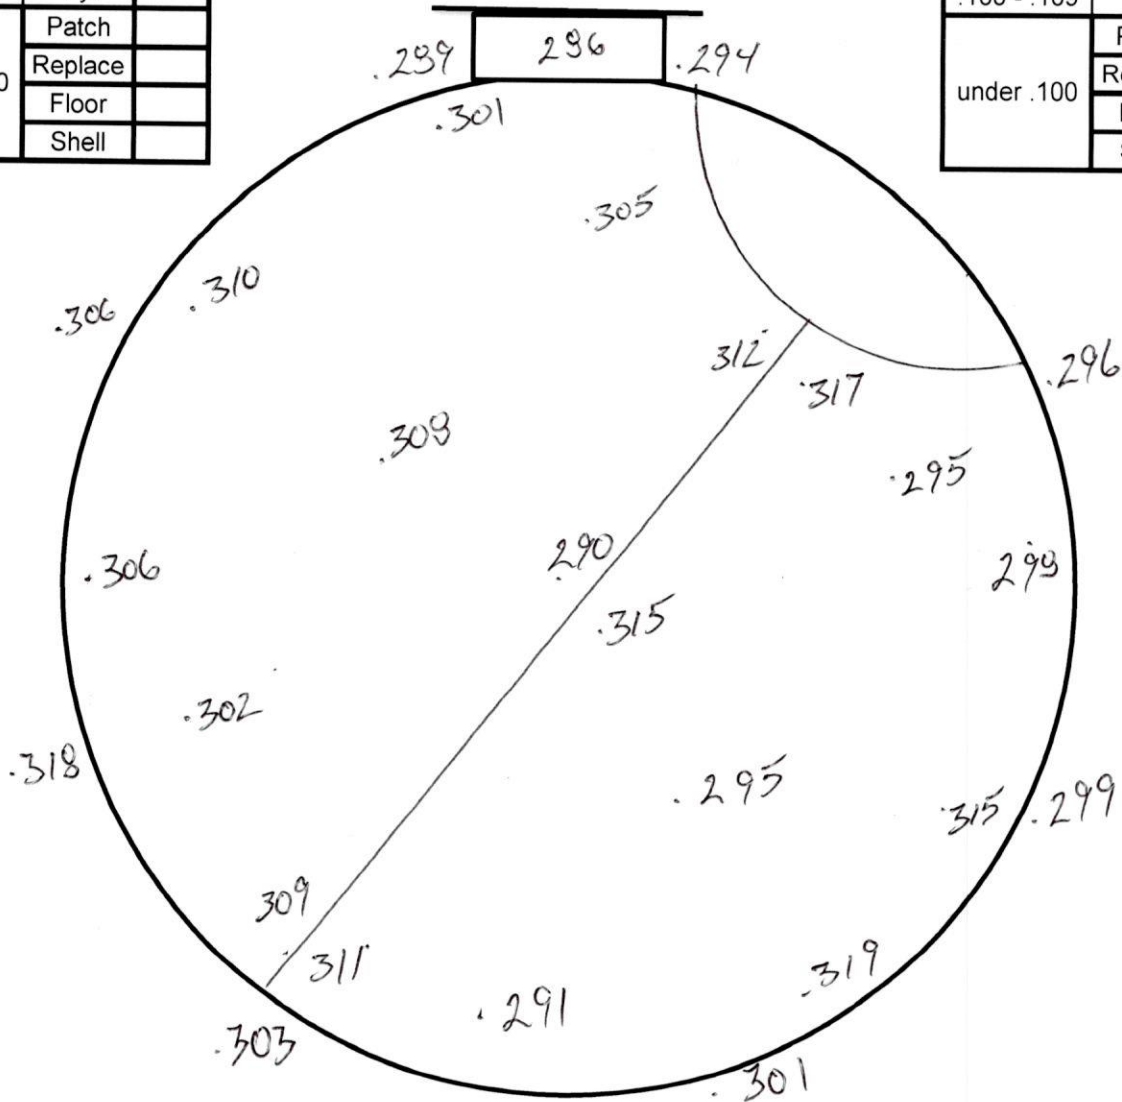
5-areas of Internal coating on the shell require patching, 12 areas on the Floor Area burnt by welding
 Recommend stripping insulation from the top of the fire tube burner, Manway, Vault to prevent UIC
 Recommend stripping bottom 2" of Insulation and painting black to prevent UIC
