Tank Inspection Report

NONDESTRUCTIVE INSPECTION REPORT

CA1101-NDT-498

Item Inspected: 1000BBL Tank

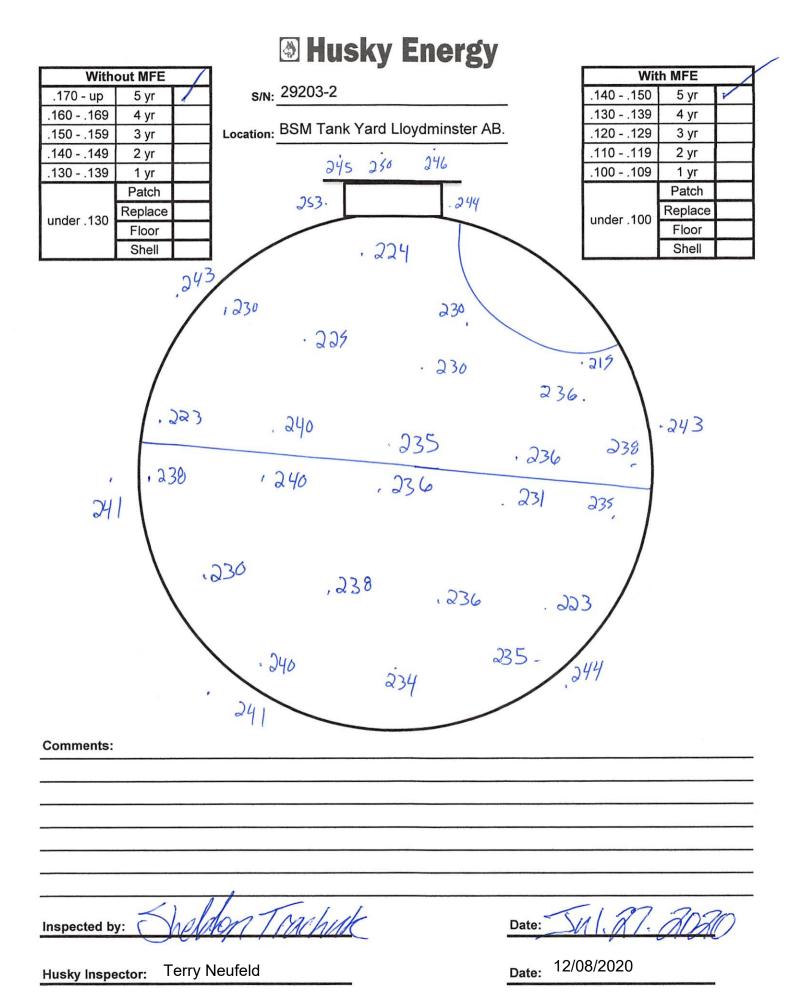
Notes
"Rusty Seepage" Evident at roof level - Possible Corrosion Under Insulation. Monitor are
Tank is Unhooked and in Boneyard
-Slight "Bulging" of insulation at roof level
Tank is in "As New" condition and has no sign of ever being in service.

Rusty seepage evident, possible sign of Corrosion Under Insulation in area - monitor roof level.
