Aerial Flare Stack Inspection Report

12th June 2018

Aerostar Drone Solutions (Aerostar) was requested to perform an Aerial Inspection on the Flare Stack (Serial Number 11170) located at Minehead 03-06-049-18 W5M Compressor Station.

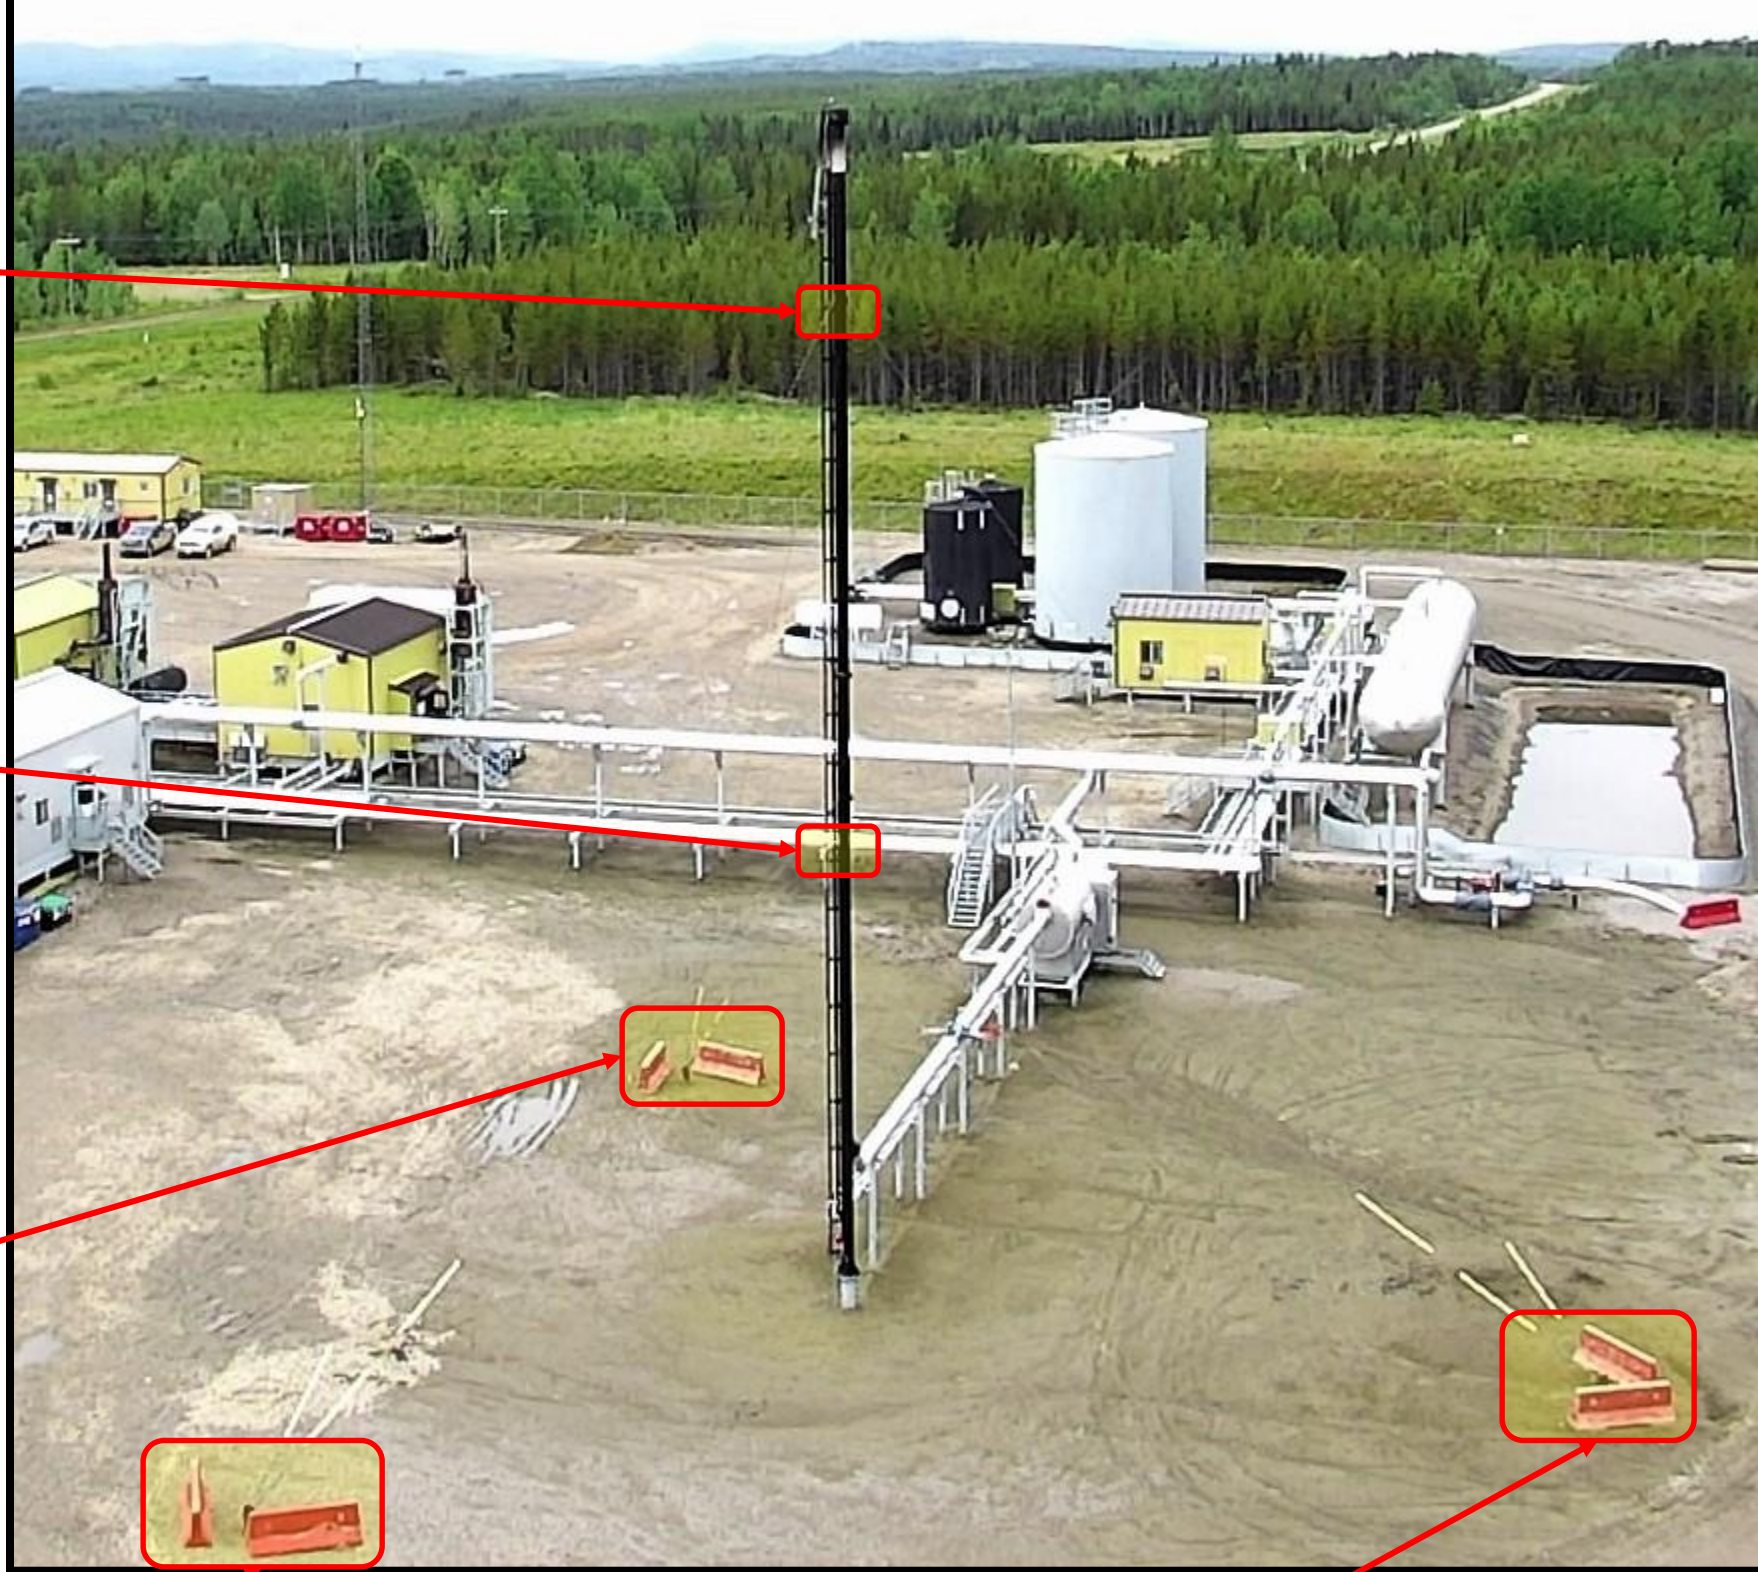
- Please note that in figure below the Flare Stack is shown with the respective spacing requirements
- The Alberta Forest and Prairie Protection Regulation states that “No person shall flare gas at the end of a vertical pipe unless the base of the vertical pipe is located at least 30 meters, or such other distance as may be specified by a forest officer, from any timber, vegetation or combustible material.”
The area around flares and incinerators must be free of fire hazards
- The red ring indicates the 30 meters (98.4 feet) radius required by AER.
- The yellow ring indicates the distance to the closest combustible material/vegetation of 33.6 meters (110.2 feet)

The AER recommended zone seems clear of combustible vegetation.
