Equipment #: 66174963  
 Area: AN-Blackfoot  
 Cost Centre: /LLOYD

**Tank Inspection Report**

ULTRASONIC TESTING REPORT

UT-67-1140

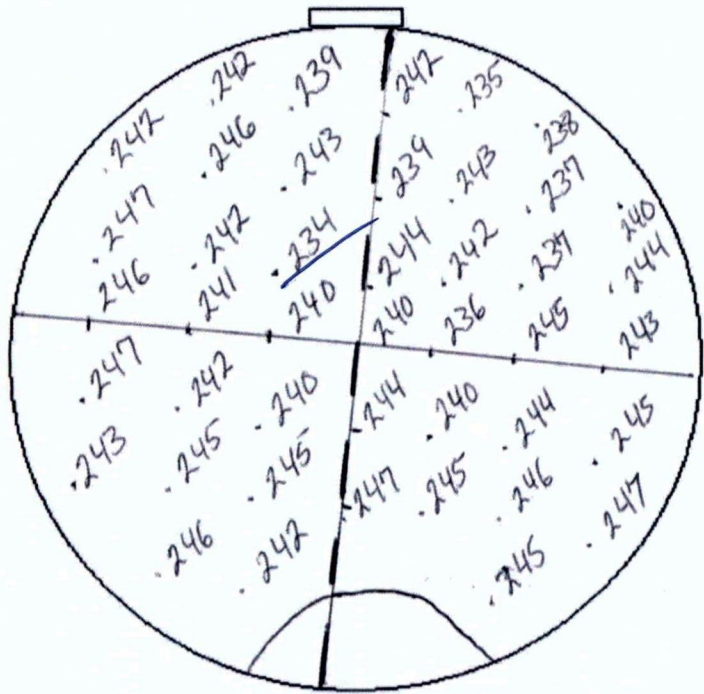
T11	Floor	<u>GOOD</u>	FAIR	POOR	<u>LOW =&gt; 0.234"</u>
V9	Shell	<u>GOOD</u>	FAIR	POOR	<u>LOW =&gt; 0.237</u>
V10	Roof	<u>GOOD</u>	FAIR	POOR	_____
V28	Firetube	<u>GOOD</u>	FAIR	POOR	INTERNAL: <u>GOOD</u> BOWED OVALLED FLANGE LEAKING: YES <u>NO</u>
V8	Nozzles	<u>GOOD</u>	FAIR	POOR	_____
V7	Welds	<u>GOOD</u>	FAIR	POOR	BACKWELDING REQ'D: YES <u>NO</u>
V21	Anodes	<u>GOOD</u>	FAIR	POOR	<u>N/A</u>
V27	Coating	<u>GOOD</u>	FAIR	POOR	TYPE: <u>N/A</u>

LOW FLOOR => 0.234  
LOW SHELL => 0.237
