Tank Inspection Report

S/N: 29085-1 (TANK 2)

Client: HUSKY OIL OPERATIONS
IRISNDT #: LYN1900860
Location: 102/ 9-11-47-5 W4M
Item Inspected: 1000 bbl tank 2 S/N# 29085-1

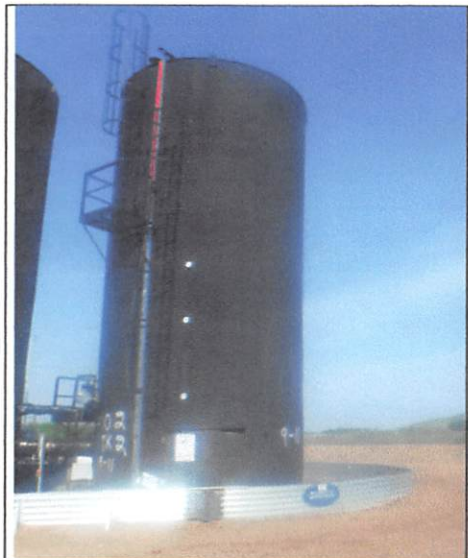
1000bbl tank 2 S/N# 29085-1: Temp collar was leaking, insulation stained. the insulation was removed and appeared to be leaking from the fitting the fitting. L&L removed the fitting and repaired the threads, monitor to ensure leak has stopped. no additional repairs required. the tank is in good overall condition for a 5yr turnaround.

stained insulation, leak at the temp collar.
