FIRED HEATER INSPECTION REPORT

LSD: 12-05-054-20W5M

Date: May 11, 2016

SAP Equipment ID: 66068448 & 66068278

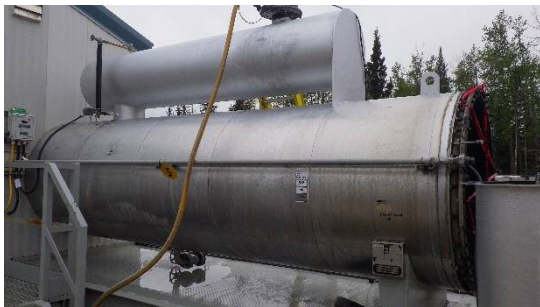
Vessel Overview

Vessel and piping is secured. Vessel is set on saddles, anchor bolted to floor outside of building and welded inside of building. The anchor bolt holes allow room for movement of vessel. The vessel is insulated/clad. Cladding is in good condition. The piping is insulated/clad in most sections. Cladding is in good condition. The areas with no clad are painted. Paint is in fair condition with failures noted. No external pitting located at these sections. Data plate is secured and legible. No short bolting found. Ground cable located. Gauges are clear & legible. Exhaust stack is in good condition. No warping noted and attachments are secure. Burner is in good condition, attachments are secure. Burner and Exhaust stack were removed for T/A. UT was done by Streamline Inspection May, 2016. UT was also performed on the bottom drain nozzle. The following was recorded: Nozzle- 2.375" O.D.; Nominal 0.154"; Low reading 0.136"; Avg reading 0.148". This is a 90 deg. elbow. Minor erosion was detected.

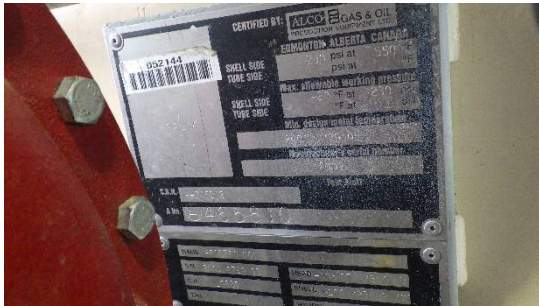
Process Coil Data Plate

Coil Prov.# A0465810. See coil#1, radiant data for data plate info. Coil PSV vents to flare. The coil psv is located off of Separator A0465811 west shell. PSV was removed at time of inspection for servicing.

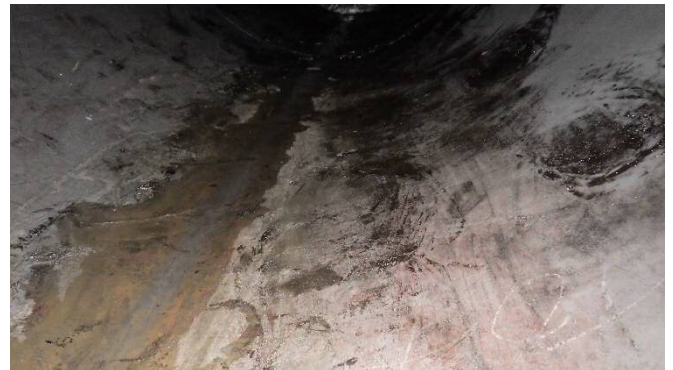
Internal shell overview

East shell (Can 1): Good condition, no internal pitting/corrosion or mechanical damage located. The attachment welds are in good condition and secured. The fuel gas line is secured and in good condition. No warping or mechanical damage located on coil supports.

West shell (Can 2): Good condition, no internal pitting/corrosion or mechanical damage located. The attachment welds are in good condition and secured. No warping or mechanical damage located on coil supports.

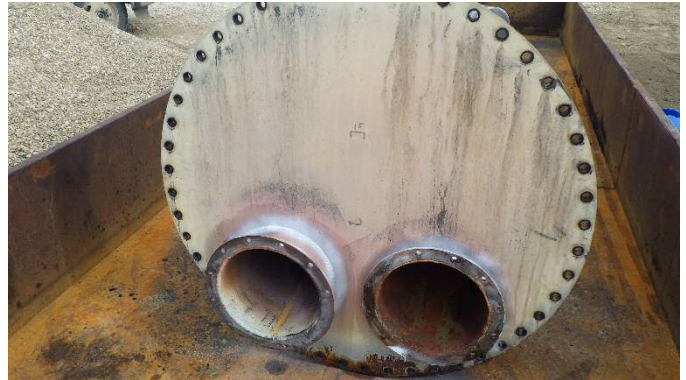
Tube Sheet Overview (Atmosphere side)

Tube Sheet: The tube sheet is in good condition. No warping or mechanical damage noted. The gasket face is in good condition. No pitting/corrosion noted at the time of this inspection.
