## Tank Inspection Report

Location: 121/B14-11-49-27W3

Client: HUSKY OIL OPERATIONS LIMITED  
IRISNDT #: LYN1801173  
Location: 121/B14-11-49-27w3  
Item Inspected: 1000BBL Tank

**Tank sn# G00 297 S1**

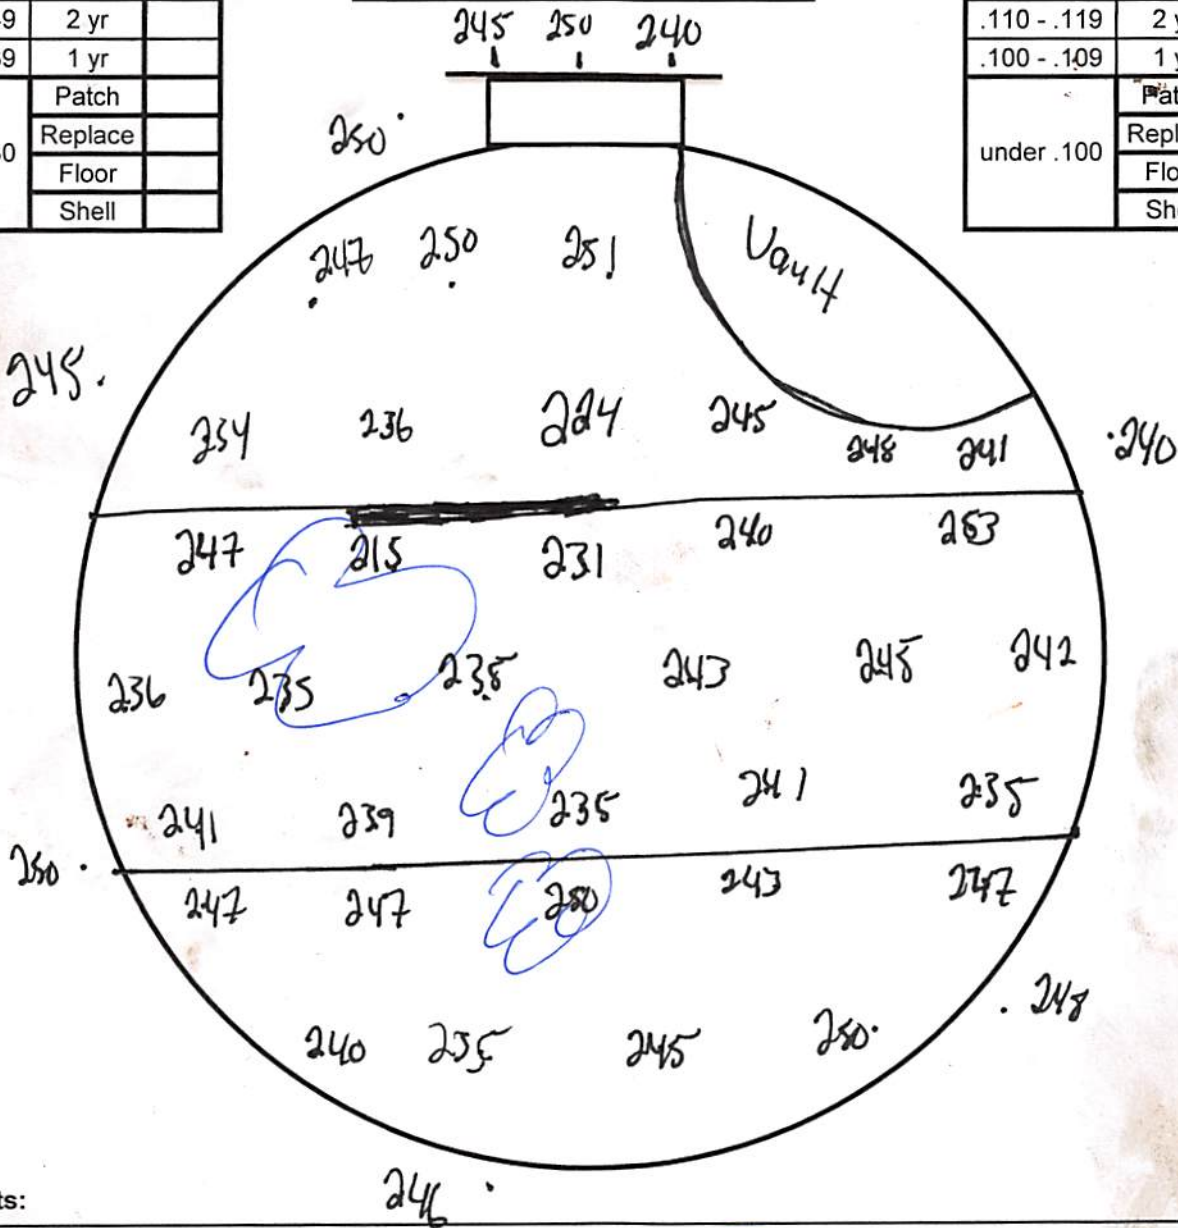
- Fix string marks on floor =

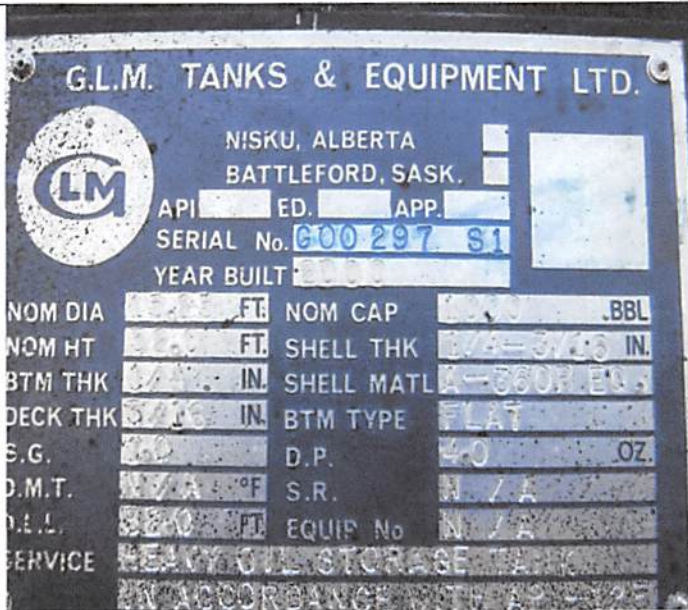
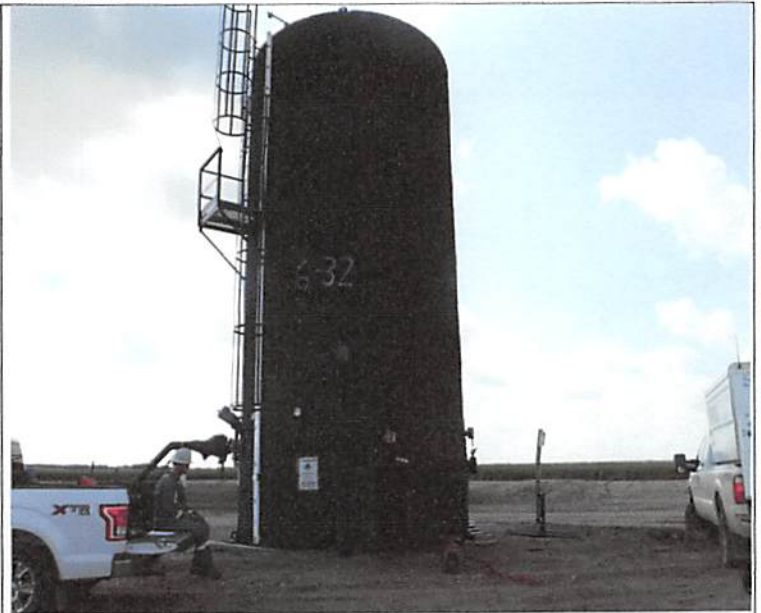
- Moderate leaking evident at firetube flange - area of oil appeared to be seeping from firetube throat - area was stripped and no sign of hole / corrosion was evident in area - Heavy leaking evident from gasket area - Recommend new gasket and monitor area
- Fill/Grind sting gouges in floor
- Brace 1" Vault riser

Area of insulation stripped - No corrosion / hole evident - insulation oil soaked
