PRESSURE VESSEL & COLUMN INSPECTION REPORT

LSD: 08-02-050-07W4 **Date:** 2017-01-30 **SAP Equipment ID** 62068385

DISTRICT:	ALBERTA NORTH	FACILITY:	MANNVILLE/ SWIMMING	LOCATION/LSD:	08-02-050-07W4
EQUIP NAME:	GLYCOL CONTACTOR			PROV REG No.:	0244337
SERIAL No.:	LS-3771	Equip No.:		National Board No.:

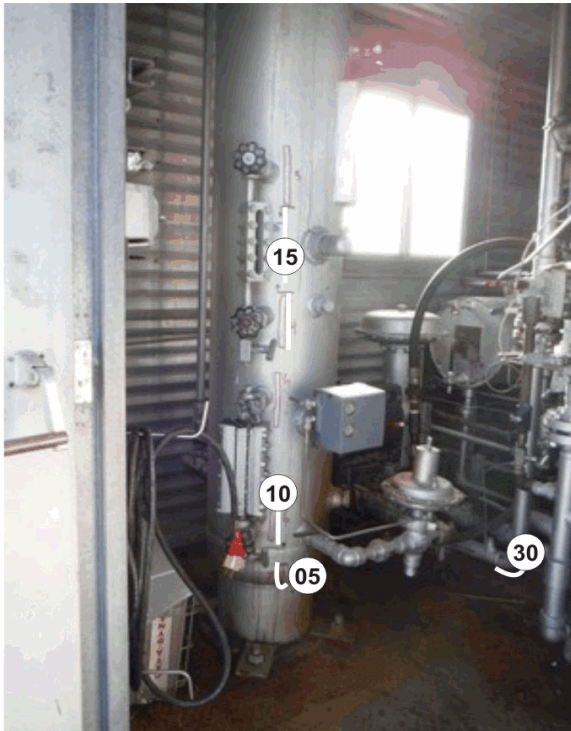
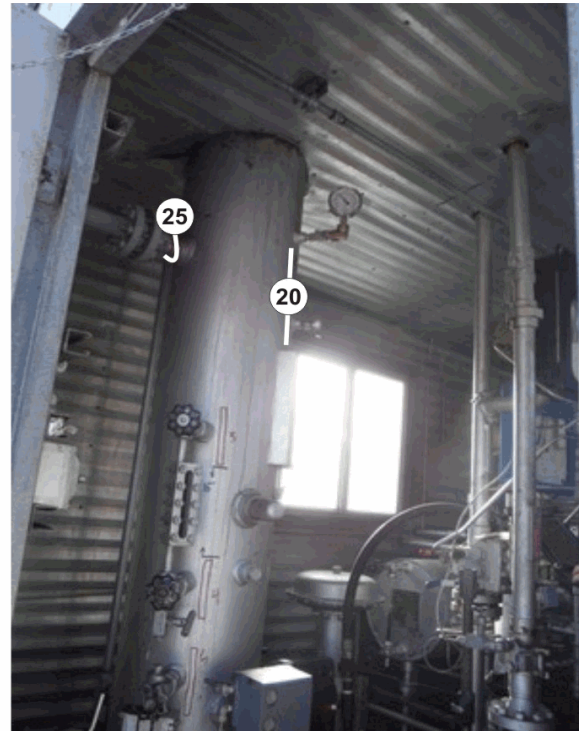
EXAMINATION ILLUSTRATION

PSV DOES NOT HAVE OUTLET PIPING ATTACHED. IDR ATTACHED
 PSV IS NOT POSITIONED VERTICALLY APPROX-45 DEGREE ANGLE.

INSTALL OUTLET PIPING ON PSV TO DISCHARGE IN A SAFE LOCATION. RE-INSTALL PSV IN THE VERTICAL POSITION OR OBTAIN PERMISSION TO OPERATE PSV IN NON-VERTICAL POSITION FROM MANUFACTURER.
