# Pressure Vessel External Visual Inspection Report

Equipment ID: 62066206

Description:	TREATER, H-100
Asset Type:	Treater

# Pressure Vessel Internal Visual Inspection Report

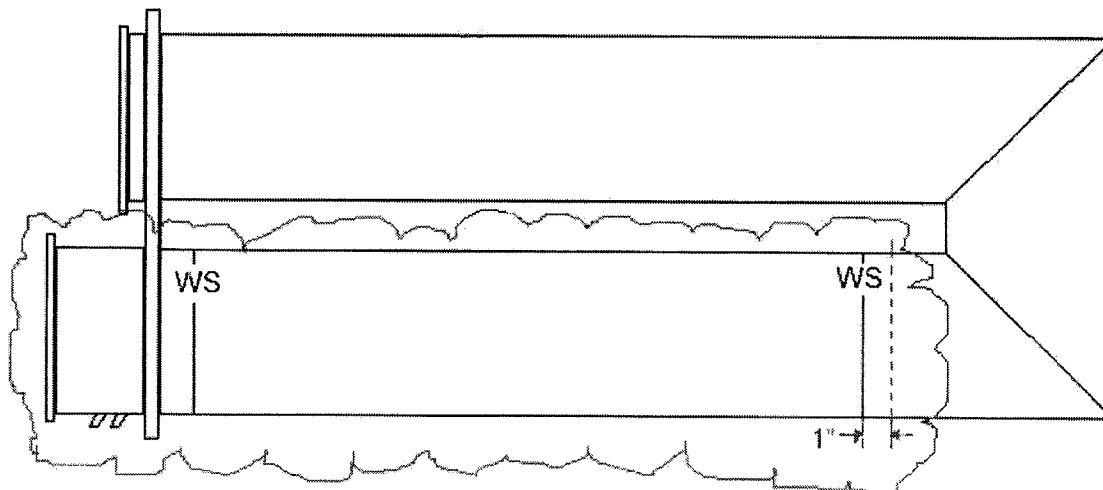
The treater was down for turnaround. The firetube was sandblasted and brought to L&L Oilfield Maintenance. The burner leg was bowed with hot spots and will be replaced through the flange to 1" past an existing circ weld. IRIS NDT is scheduled to perform 100% MPI on welds. If cracking is found stop the repair and contact Marie to reassess.

- 1) Remove the firetube from the tubesheet weld by suitable methods such as air-carbon arc gouging, and cut out the degraded area of pipe 1 inch beyond the existing circ weld repair on the leg.
- 2) Bevel dress the firetube and tubesheet per original detail. Parent material to be cleaned to shiny metal at weld and adjacent 50mm minimum. Perform MPI on prepared surfaces (below).
