# Storage Tank Visual Inspection Report

**ABOVE GROUND STORAGE TANK  
API STANDARD 653  
OUT-OF-SERVICE  
FINAL INSPECTION REPORT  
RANGER INSPECTION™  
JOB # 22669  
(Revision 1)**

**HUSKY ENERGY**

**TANK # T-107A**

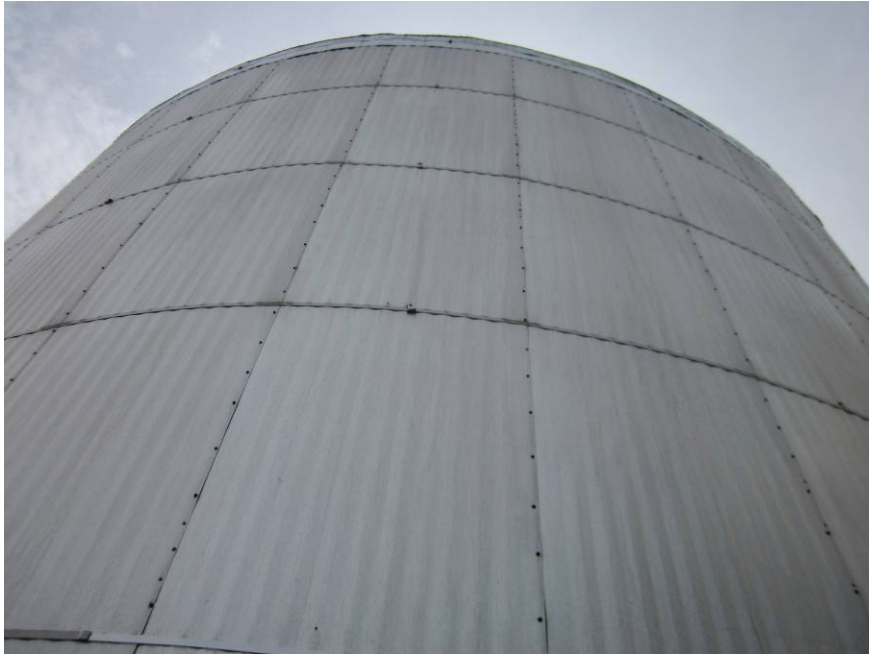
**Photograph #27: Insulated Shell Plate**

ID	Description	Condition	Location	NCR	Comment
T6	Ladder/Stairway	Fair			Acceptable
T7	Platform	Fair			Acceptable
T8	Electrical Ground	Yes			Acceptable
T12	Level Gauge	Yes			Acceptable
T13	Bottom	Fair			Acceptable
T14	Secondary Containment	No			
T15	Shell	Fair			Acceptable
T16	Roof	Fair			Acceptable
T32	Foundation	Fair			Dirt and gravel on tank floor lip.
T41	Connections Other (Please explain)	Fair			Associated Piping - Acceptable
T43	Nozzles	Fair			Acceptable
T46	Manways/Hatches	Fair			Acceptable
T49	Bolting	Fair			Acceptable
T50	Flanges	Fair			Acceptable
T61	Insulation Other (Please explain)	Fair			Several joints of the cladding covering the insulation are not properly sealed.

The joints of the cladding should be properly sealed to prevent moisture from entering and damaging the insulation.  
Remove the dirt gravel etc. from the tank floor lip.
