2023 INSPECTION & TEST PLAN

STATIC DATA					
Plant	Manitou	Eq#	62066330	Manufacturer	Universal Industries
LSD	01-30-044-26W3	Tag #	T-107	Serial #	95 01 17 8944

**QNATANK-7 10Y Code Inspection Tank 2000 to 10,000 bbl,
Fully Coated**

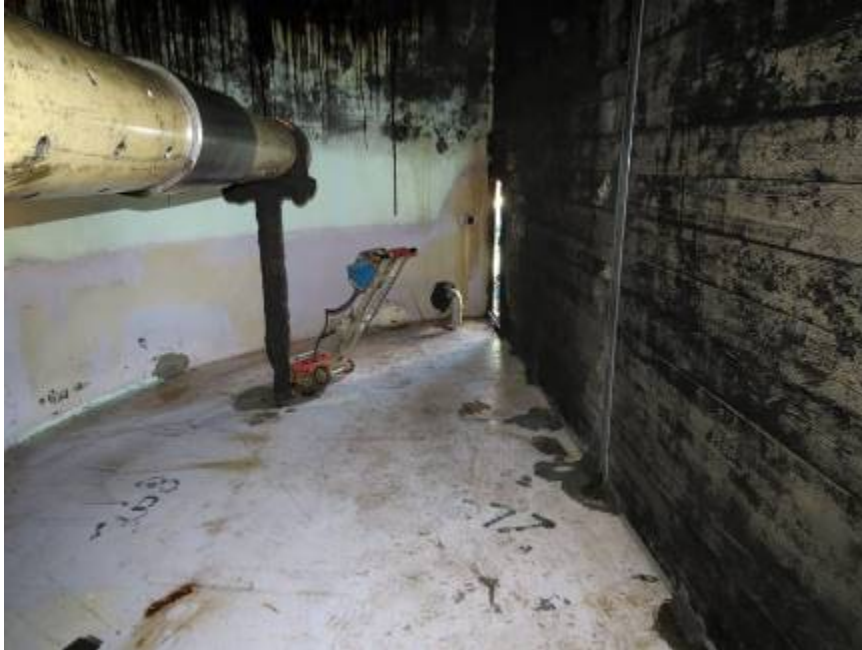
Photograph #6: Bottom Plate Overview

- 1.) A Magnetic Flux Leakage (MFL) scan was performed on accessible areas of the tank bottom plate. No indications of underside material loss were identified. The MFL threshold for the scan was approximately 0.030 inch.
- 2.) Forty-six (46) areas of coating failure were identified and marked on the tank bottom plate.
- 3.) The bottom plate was visually examined for topside pitting. Fourteen (14) areas of isolated pitting up to 0.150 inch deep were identified.

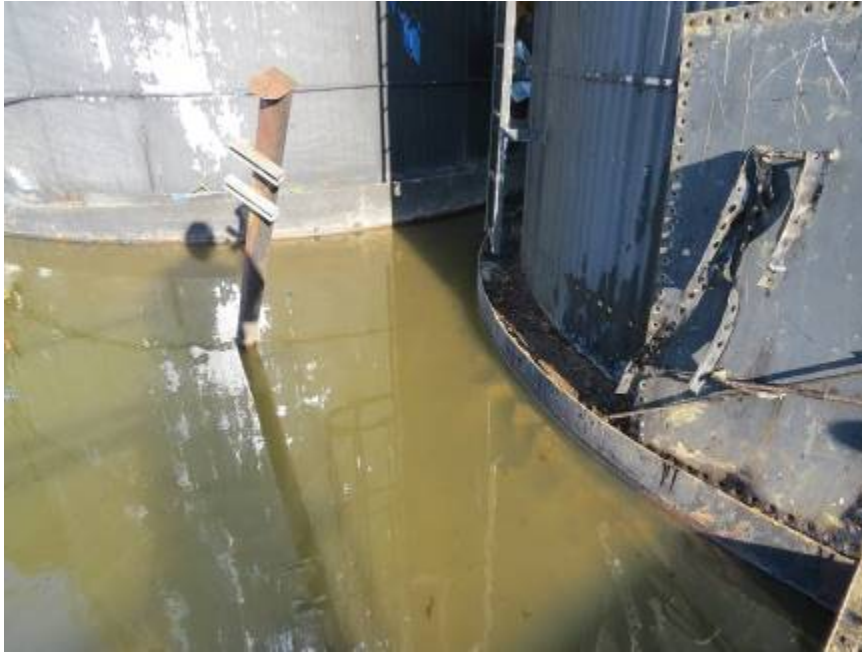
Photograph #13: Foundation Overview

- 1.) The foundation was visually examined from accessible areas. The tank is sitting on an elevated earth and gravel pad, contained within a steel ring. It was found that the tank is sitting below grade; therefore rain water is not directed away from the bottom plate.
- 2.) The shared tank berm was full of water at the time of inspection.

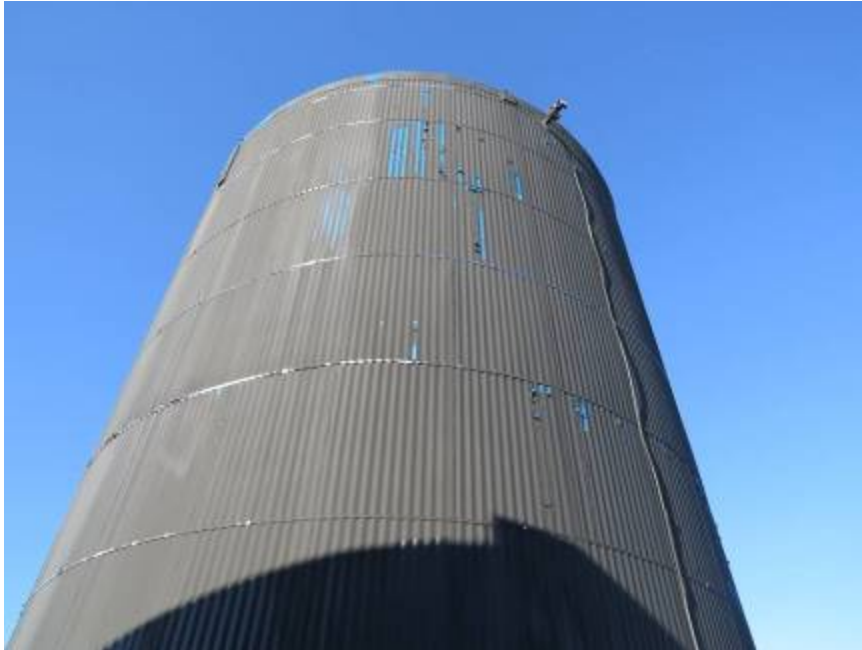
Photograph #16: External Shell Overview

- 1.) A limited visual inspection was performed on the external shell plate due to the shell being covered by insulation and flashing.
- 2.) The internal shell plate was visually examined. No significant deformation was observed. Seven (7) coating failures were identified and marked on the shell plate.
- 3.) Random ultrasonic (UT) thickness readings were taken on the first course shell plate. No material loss was observed or recorded. Refer to Table A - Manual UT Shell Plate Readings – Course # 1, for additional data.
- 4.) One (1) area of shell pitting was observed, the pit was recorded at 0.090 inch deep.
