STATIC EQUIPMENT INSPECTION REPORT - Exhibit # 300

District: Big Valley Facility: Compressor Lsd 05-26-035-21W4M Skid: _____

Item Insp.: Inlet Separator

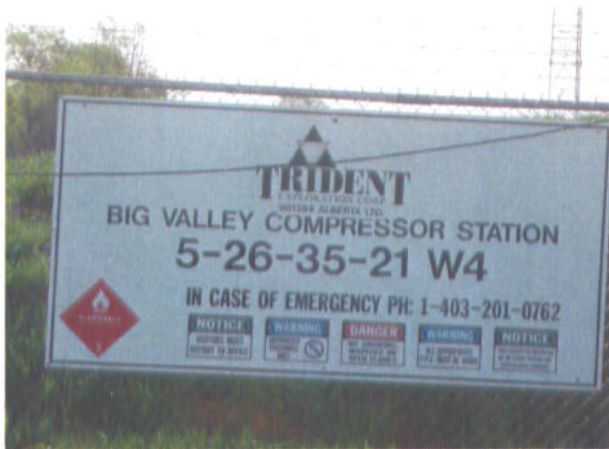
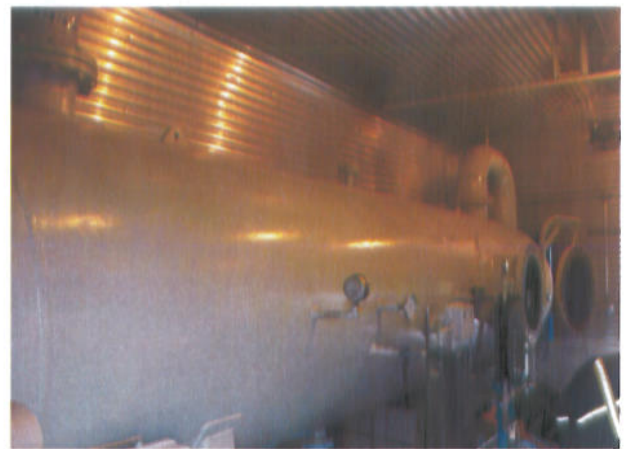
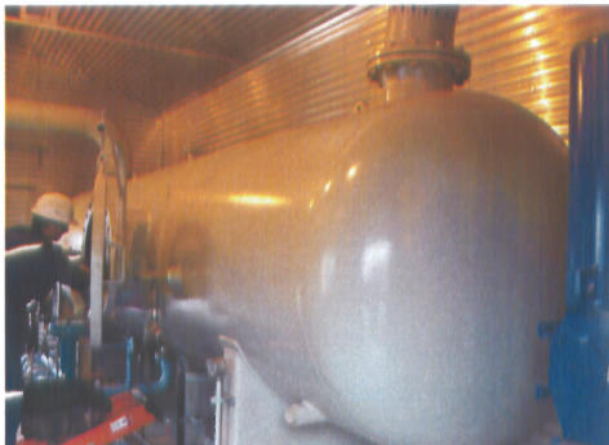
PICTURES:

-Interior of vessel is in "as new condition"
-There is no internal coating. Fabrication markup is evident.
-No deformation, no distortion, no pitting, and no general metal loss was noted.
-The demister is clean, flexible in position, and secure.
-The Vortex breakers are secure.
-The diverter is secure.
-A 6" pig was removed from the North 4" drain. All other nozzles are open.
