# **Existing Equipment Integrity Assessment Report**

u.			L.	Vessel	Data								ı			
Vessel D	escrip	tion	BPV-0	66726	– 1 <sup>st</sup> S	tage S	crubb	er	R <sup>-</sup>	Г :	1	PV	۷H	Γ⊠	] Y	es [	□ No	Pa	rtial [	
A# / NB	# A	05450	<b>)26</b>		Seri	al#	0509	4-01	•			CR	N ‡	‡	R34	442.21	.3			
Manufa	cturer	EF	X Compi	ression	1							Ma	anv	vay[		Yes	⊠No	Siz		
Owner 1	Гад	N/S			Skid	Co	omp 9	Skid #05	0903			OD	1	24"			Leng	th	6'	•
MAWP:	1 🗵	Shell	ell Tube 285 psi kPa MAWT C 120 F MDMT C -20 F								F									
MAWP 2	2 🗆	Shell	□Tube		psi		kPa	MAV	VΤ		С			F	М	DMT		С		F
Operatii	ng Pre	ssure		psi			kPa	Oper	ating	Temp	)		С			F Fla	nge Ra	ting	# :	300
Process	Condi	tions:	⊠ Swe	et 🗆	Sour						Inte	rnal	Coa	atin	g:	N/S				
Product	: ⊠G	as $\square$	Water	☐ Air	· 🗆 E	Effluen	t 🗆 (	Other:												
PSV #1 Data																				
Owner ID/Tag 10 Yoho PSV Location Piping																				
Manufacturer Crosby Model # 1.5F2JOS-#15J																				
Serial # 1101-1707-091526 Mfg Date 01/17

VESSEL DATA										
Vessel Description: 1st Stage Suction Scrubber										
A No.:	0545026	Vessel ID:	N/S	Manufacturer:	EFX Compression					
CRN No.:	R3442.213	Year Built:	2005	District:	Inga, BC

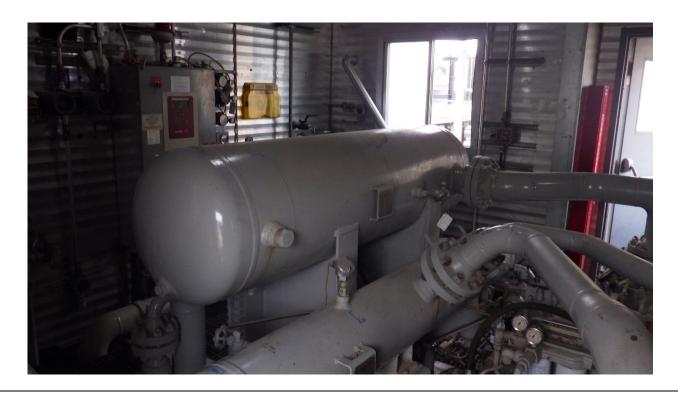
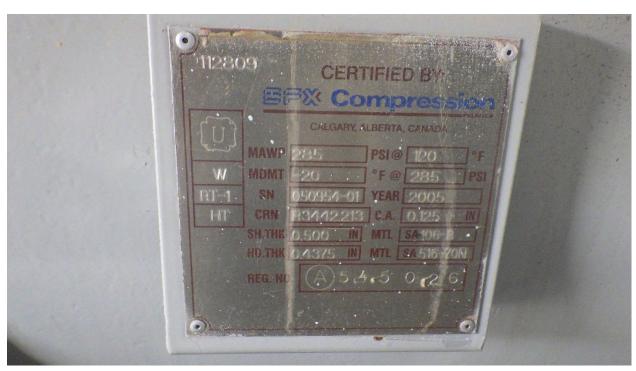
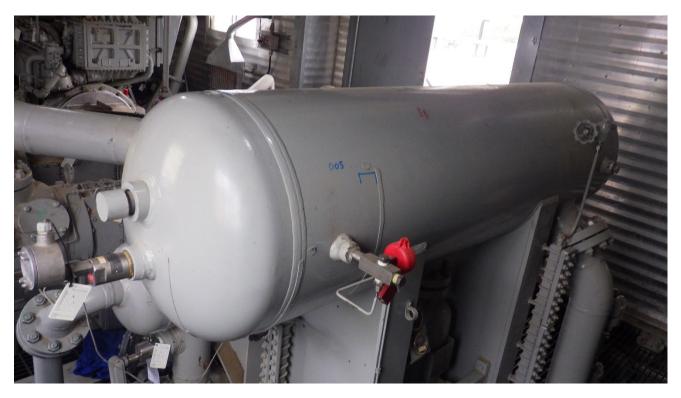
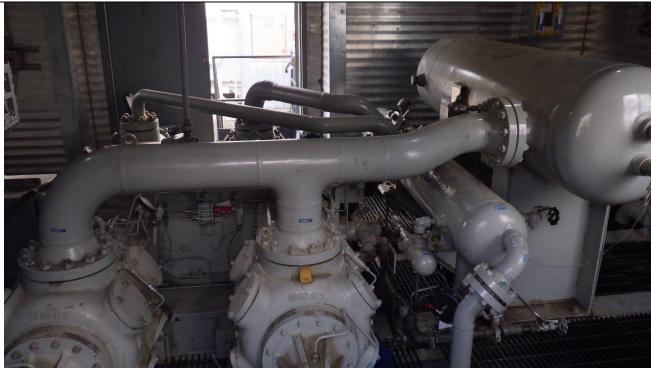
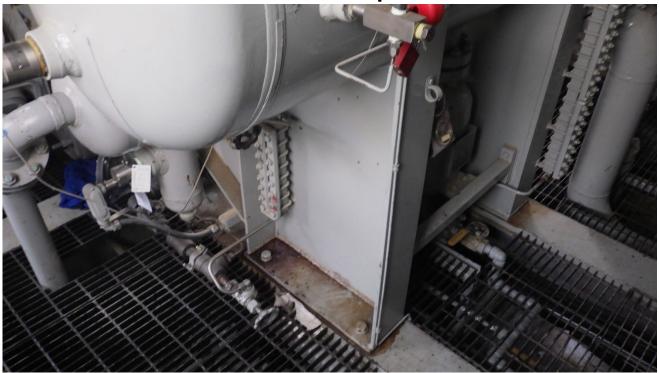
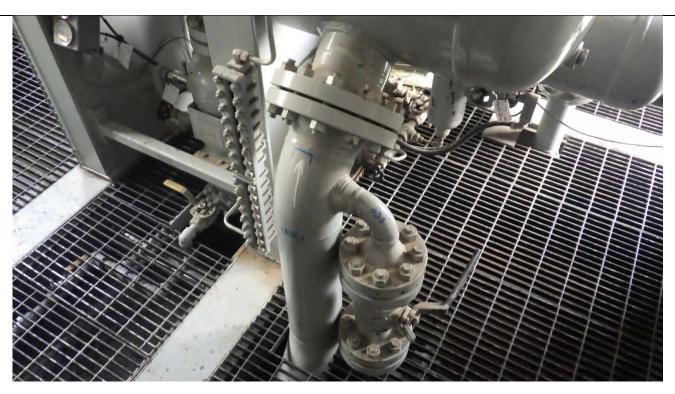
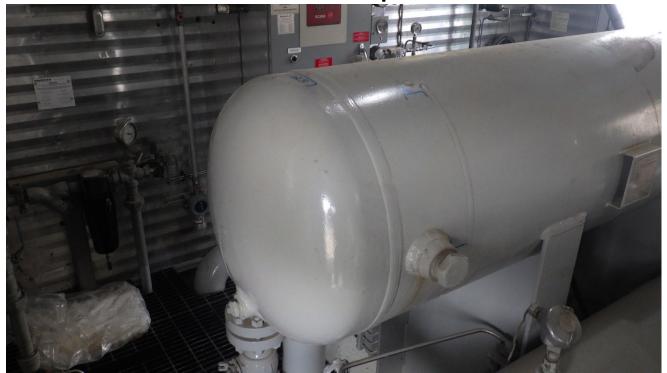
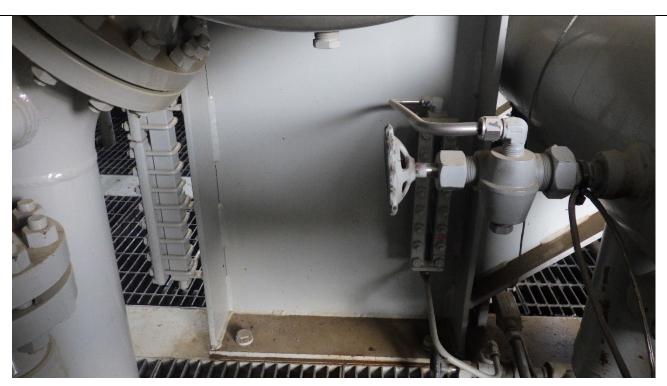
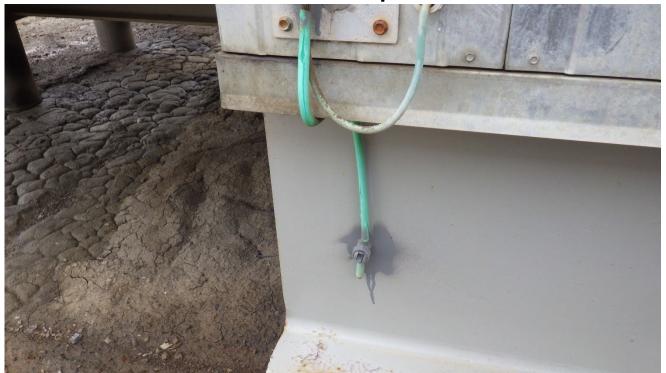
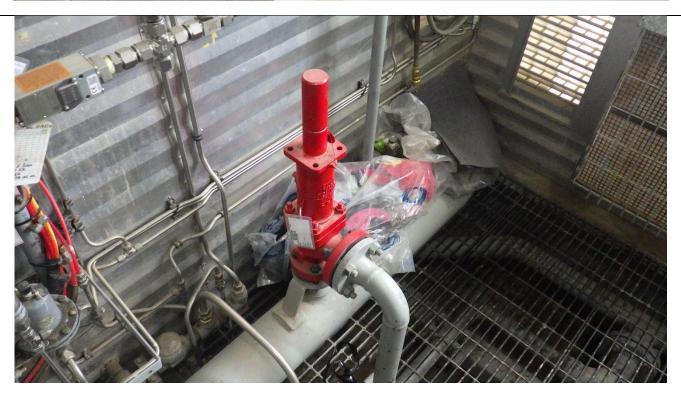
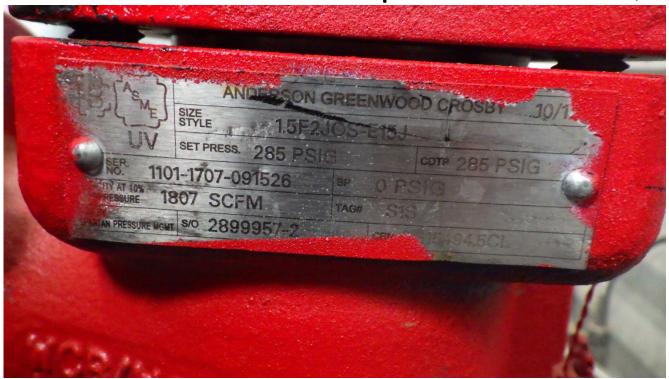
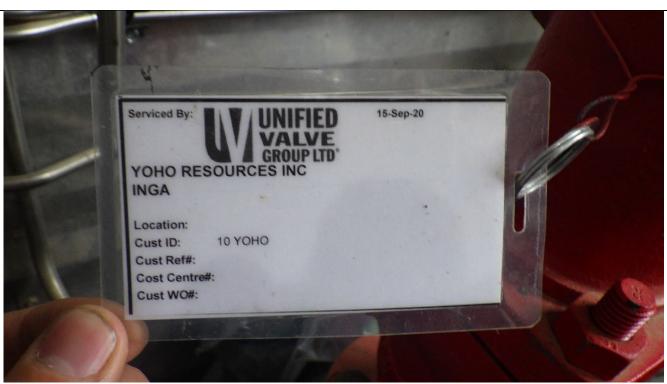
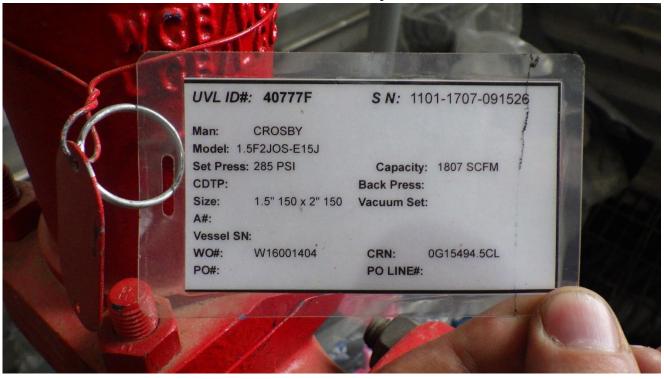
# Vessel External Inspection PHOTOS

External Inspection	Good	Fair*	Poor*	N/A	External Inspection	Good	Fair*	Poor*	N/A
Skid Foundation/Supports	X				Ladder(s)/Platforms				X
Insulation/Cladding				X	Gauges				X
Vessel Nameplate	X				Valves	X			
Vessel Saddle/Skirt/Supports/Bolts	X				Piping	X			
Vessel Paint/Coating	X				Flanges/Bolting (per Code)	X			
Vessel Shell	X				Piping Support	X			
Vessel Head	X				Catadyne Heaters (zip ties)	X			
Nozzles	X				Surface Staining of Ground	X			
Pig Traps (ie evidence of hammering)				X	Signage (i.e. stand alone)				X
Regulators Vented	⊠ Yes	s 🗆	No		Vessel/Skid Grounded	⊠ Yes		No

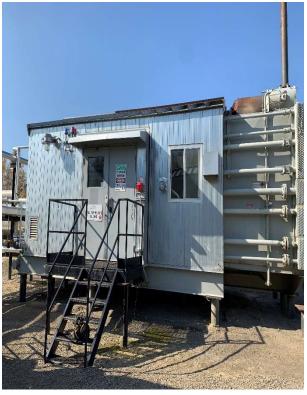
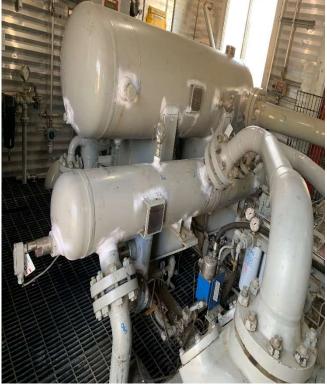
#### Compressor C-100:

**Items Inspected:** D category welds associated with C-100, C-200 & C-300 compressor bottles and gusset welds associated with the pressure release device.

All the areas inspected did not exhibit any relevant indications of defects/discontinuities at the time of inspection.
