Tank Inspection Report

Location: 102/11-14-49-2W4M		Tank Type: Sal	es	Date: 18-Sept-19
Mfg: Universal	Year blt	. <u>2010</u> s	_{S/N:} 021080	-4 CAP: 1000 bbl
Floor Thk: 1/4"	Shell Thk: 1/4"	X 3/16"	Roof Th	k:_3/16"
Requisitioned by: Arnie Domes		Approver: Scott S	Stafford	Approver Code: 2Z-2020575
WO #: 81422566 PO#: 2	3401358779	CC:		SAP #: 66168164

NONDESTRUCTIVE INSPECTION REPORT

IRISNDT #: LYN1901578 Location: 102/11-14-49-2W4M Item Inspected: Sales tank

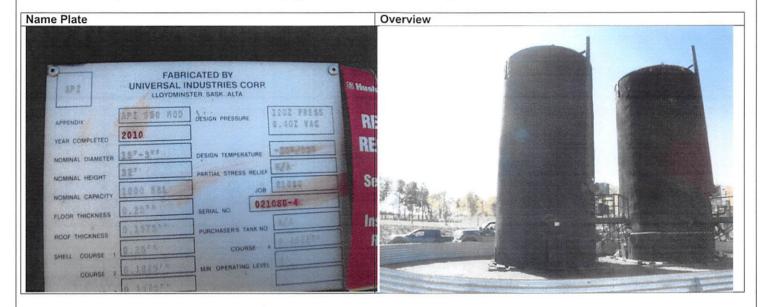
A Visual examination and UT thickness check was carried out on the following 1000Bbl tank for the purpose of determining tank condition and inspection interval. See attached pages for UT thickness readings and observations.
