## Crescent Point VISUAL INSPECTION REPORT - PRESSURE VESSEL

Installation External									
Date:	February 7, 2018	Description:	🗹 Vessel 🔲 Exchanger 🗔 Furnace Boiler						
Inspector:	Ryan Hogg	Unit #:	Equip #:	848874					
Agent Co:	Agent Co: 101292687 Saskatchewan Ltd		Filter						
		Jurisdiction	CRN #:	T4606.4					
Province:	Manitoba	Manufacturer:	ESS Corp						
Area:	Run 009 – Ingoldsby/Pierson	Year Built:	2014 <b>S/N</b> :	4550 B					
Subarea:	Battery 09-32-001-28W1	Location/LSD	BAT/09-32-001-28W1

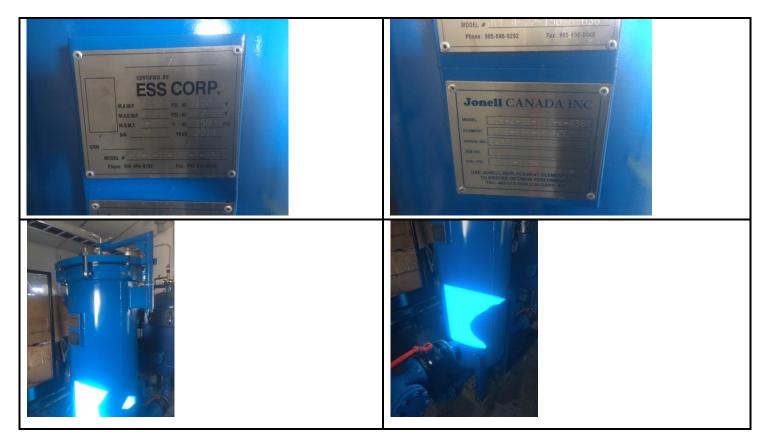
2.0 Non-	-Fired	Pressure	Vessels																	
	spection ummary																					
100	anniai y	Filter is acceptable for service at the time of inspection. Bottom head was UT'd readings throughout w internal corrosion – design is same as 4550 A which was open at the time of inspection and there is no																				
							s straight th				эрссио						/443.					
Γ	L.	Recommended Actions:												NCR/IDR

UT after 1 yr service due to corrosion issues in the adjacent filters. Filters should be cleaned out on a regular basis when switching to opposite bank of filters.
