## Ultrasonic Corrosion Survey

Date	Feb 3, 2025
Report #:	UT-2379-1

Client:	West Lake	LSD:	13-16-001-33 W1M	Field:	Souris Flat	Vessel:	Gas Scrubber		
SN:	116349	MFG:	Sivalls	MAWP:	125 PSI	HD Mat'l:	N/A	CA:	N/A
A#:	N/A	Year Blt:	2009	MAWT:	500°F	HD TK:	N/A	RT:	N/A
CRN:	2455.321	Length:	30"	MDMT:	-20°F	SH Mat'l:	N/A	PWHT:	N/A
NB:	16486	Diameter:	10.75"	S#:	N/A	SH TK:	N/A	UT:	0.001"

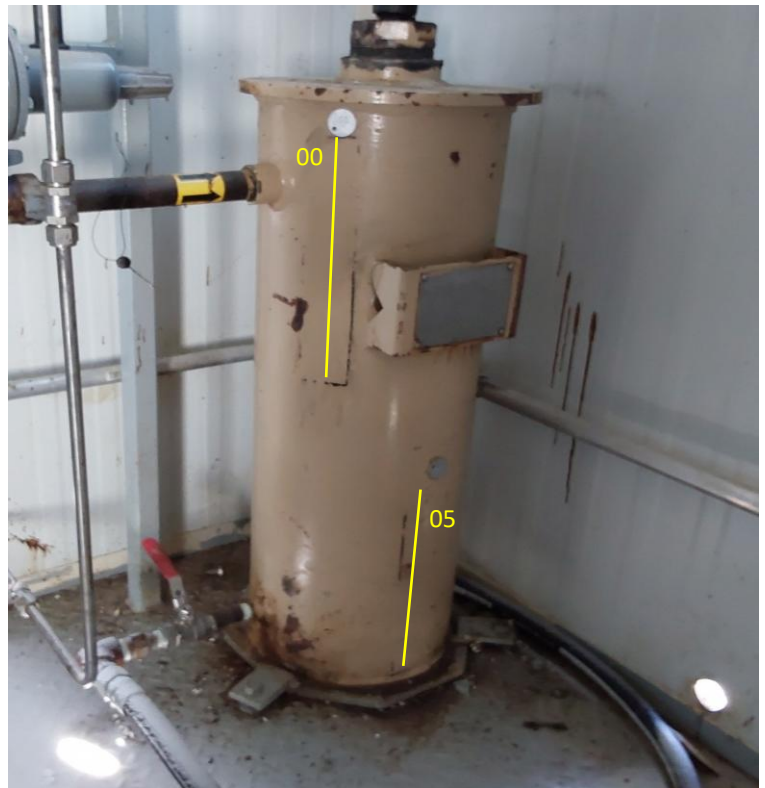
Survey #1					Survey #2				Nominal	Description
Band #	High	Low	Average	Wall Loss	High	Low	Average	Wall Loss		
00	0.250	0.245	0.248	-0.005					0.250	Top-Mid Shell
05	0.249	0.238	0.244	-0.012					0.250	Mid-Bottom Shell
