Field Inspection Report - Long_Run 172957_06/12/2013_VT_Internal

Vessel Number	172957	Vessel Name	NGL BULLET	Province	Alberta
District	TREVOR J'S FIELD	LSD	05-10-033-26W4	Location	WIMBORNE
Method	VT	Access	Internal	Cleaning	Good
Inspection Date (mm/dd/yyyy)	06/12/2013	Inspection Interval (months)	120	Next Inspection (mm/dd/yyyy)	06/12/2023
CRN	9156.3214	Skid Number	NO	Service	Sweet
Internal Access	YES	Internal Coating	No	Status	IN SERVICE
MAWP (PSI)	250	MAWP (kPa)	1723.7	Outstanding NCRs	0
MAWT (°C)	66	MAWT (°F)	150.8

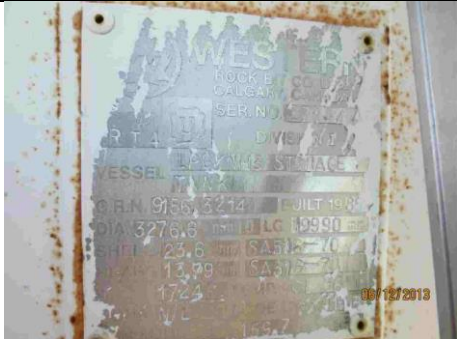
CRW 172957 A NUMBER 06-12-13.JPG	CRW 172957 NAMEPLATE 06-12-13.JPG

All visible shell surfaces and nozzles appear in good condition. Name plate is intact and legible. Vessel supports, foundation, electrical grounding and external coating appear good. Associated piping, supports and components appear in good condition and alignment with no signs of leaks or defects present at the time of inspection. No evidence of short studding or nut rounding at time of inspection.

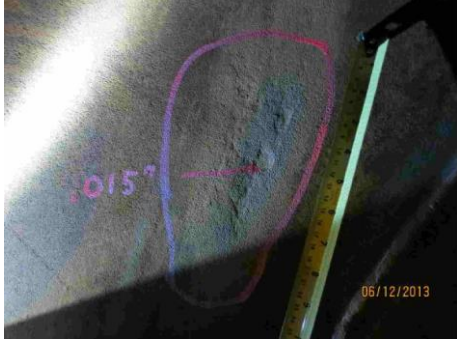
CRW 172957 LPG BULLET 06-12-13.JPG	CRW 172957 NORTH HEAD PITTING 06-12-13.JPG

The northwest head section has an arc of pitting.

UT was performed externally on these areas. UT results reveal there is minimal head loss on the northwest head section and head loss to a maximum of .049" on one spot on the southeast head as per MWS NDE report A# 172957 C31033 06-12-13.

Widely scattered pitting API 510 paragraph 5.7.e

No pit depth is greater than one-half the vessel wall thickness (exclusive of the corrosion allowance). The total area of the pits does not appear to exceed 7 square inches (45 square centimeters) within any 8-inch (20-centimeter) diameter circle and meets the requirements of API 510 for widely scattered pitting.

Maintain "on stream" Ultrasonic Corrosion survey monitoring of the vessel components and associated piping with special attention to the areas of pitting on the northwest and southeast head sections.
