FORM: IMS001 – Devon Standard Inspection Form

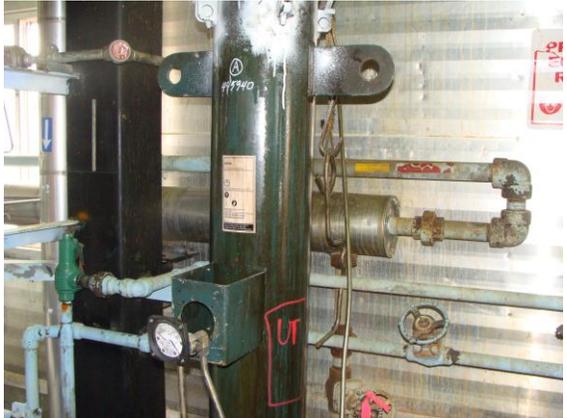
<p>Picture 1 (Desc.):</p>	<p>Picture 2 (Desc.)</p>

- Filter had possible corrosion Directly beside where nameplate is located. UT Follow up to be completed.			
Inspection Details:			
<ul style="list-style-type: none"> - Full internal inspection was completed. One area of possible corrosion was noted directly beside nameplate bracket. UT inspection is required. - No external deficiencies were noted. 			
Repairs:

- None			
NDE Reports:			
<ul style="list-style-type: none"> - Acuren MPI Report M-086670 - No Indications 			
Recommendations:			
<ul style="list-style-type: none"> - UT Inspection as stated above. - 			
Certification:			
Inspector Signature:		Provincial Certification Number:	
Date:	June 18, 2009
