## PRESSURE VESSEL & COLUMN INSPECTION REPORT

**LSD:** 06-09-050-19W5      **Date:** 2014-05-12      **SAP Equipment ID** 66048297

VESSEL STATIC DATA			
<b>Plant:</b> ANSELL		<b>OP Unit:</b>	
<b>Prov. Insp . #:</b> 0446816		<b>CRN:</b> H2451.2	
<b>Equipment Description:</b> SEPARATOR		<b>Serial #:</b> 5349	
<b>Manufacturer:</b> RJV Gas Field Services		<b>Vessel Class:</b> vessel	
<b>Internal Access:</b> No		<b>Description:</b>	
<b>MAWP:</b> 9929 kpa		<b>At Temp</b> 38 C	
<b>Code:</b>		<b>RT:</b> RT2	
<b>Diameter:</b> 406 mm <b>Length:</b> 2286 mm		<b>(T/T):</b> mm <b>OAL:</b> mm	
<b>SHELL    Mat'l:</b> SA-106 B		<b>Thickness:</b> 26.21 mm	
<b>HEAD    Mat'l:</b> SA-516 70		<b>Thickness:</b> 19.61 mm	
<b>Nozzle    Mat'l:</b>		<b>Thickness:</b>	
<b>Internal Coating:</b>		<b>Internal Clad:</b>	
<b>Manway:</b> No		<b>Inspection Port:</b> Yes	
<b>Nozzle Rating:</b> lb ANSI		<b>Painted:</b> Yes	
		<b>Insulated:</b> No

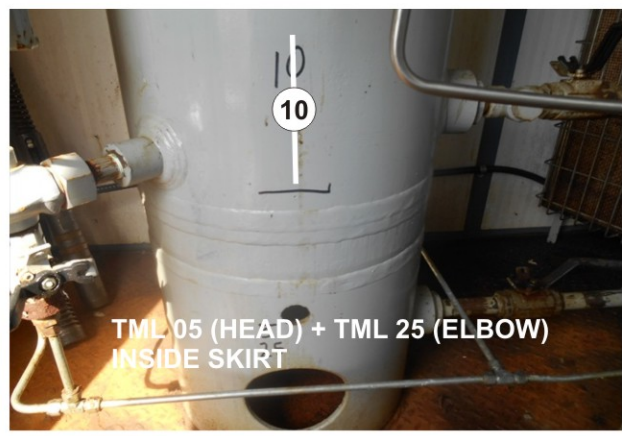
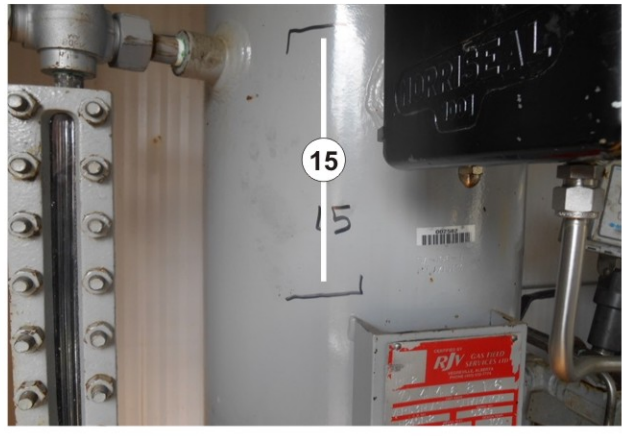
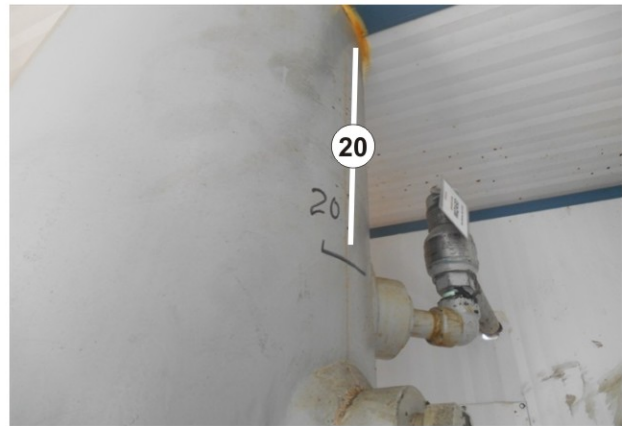
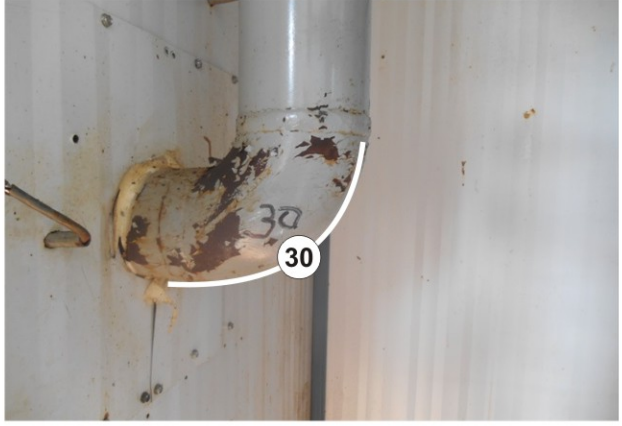
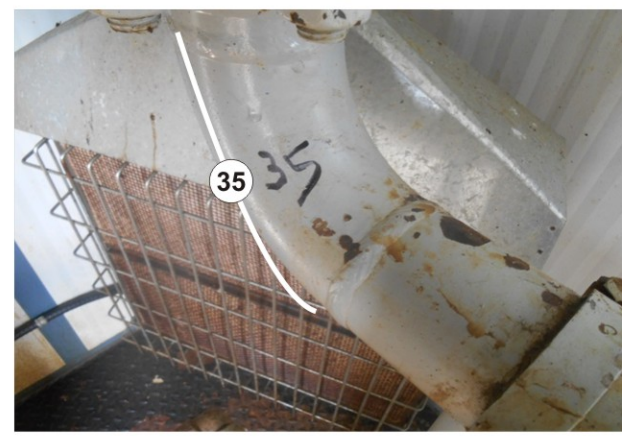
**EXAMINATION ILLUSTRATION**

CML	Nom. Thickness (mm)	CURRENT READINGS (mm)	short term corr rate (mm/y)	long term corr rate (mm/y)	remaining life (year)	Survey Date	Comments
05 (HEAD)	19.61	24.89	0.0000	0.0000	198.0	2014/05/12	
10 (SHELL)	26.21	26.34	0.0000	0.0000	198.0	2014/05/12	
15 (SHELL)	26.21	26.37	0.0000	0.0000	198.0	2014/05/12	
20 (SHELL)	26.21	26.97	0.0000	0.0000	198.0	2014/05/12	
25 (90L 2.5 XXS)	14.02	12.37	0.0996	0.0996	97.8	2014/05/12	
30 (90L 3 40)	5.49	5.61	0.0000	0.0000	198.0	2014/05/12	
35 (90L 3 40)	5.49	6.22	0.0000	0.0000	198.0	2014/05/12

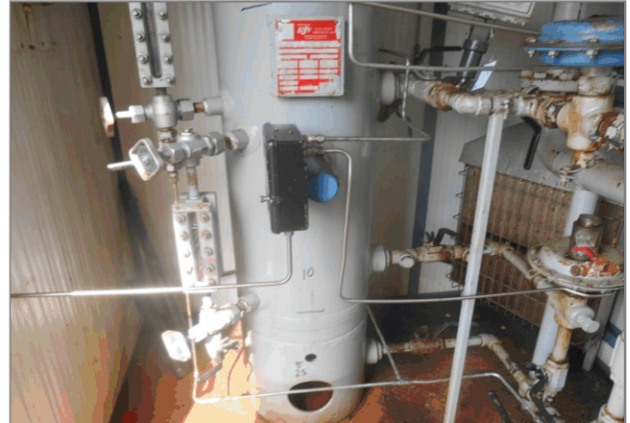
ID	Description	Condition	Location	NCR	Comments
V1	General Other (Please Explain)	Accept		No	VESSEL CURRENTLY NOT IN SERVICE AT TIME OF INSPECTION. GOOD OVERALL EXTERNAL CONDITION.
V2	General Corrosion	Accept		No	NO VISUAL EXTERNAL CORROSION NOTED.
V3	General Leaks	Accept		No	NO VISUAL LEAKAGES NOTED.
V4	Vibration	N/A		No	
V5	Dissimilar Flange Rating	N/A		No	
V6	Ladder/Stairway	N/A		No	
V7	Heads	Accept		No	
V8	Guy Wires	N/A		No	
V9	Electrical Ground	Accept		No	
V10	Painted Inactive Corrosion	N/A		No	
V11	Coating/Painting	Accept		No	MINOR PAINT PEELING NOTED ON ASSOCIATED PIPING.
V12	Expansion Joint or Bellows	N/A		No	
V13	Gauge/Site Glass	Accept		No	GAUGES ARE VISIBLE APPEAR TO BE IN GOOD CONDITION.
V14	Shell	Accept		No	
V15	Jacket	N/A		No	
V21	Support Other (Please explain)	N/A		No	
V22	Foundation	N/A		No	
V23	Anchor Bolts	N/A		No	
V24	Saddle/Skirt	Accept		No	SKIRT IN GOOD CONDITION, VESSEL WELDED TO FLOOR, VESSEL IS SECURE.

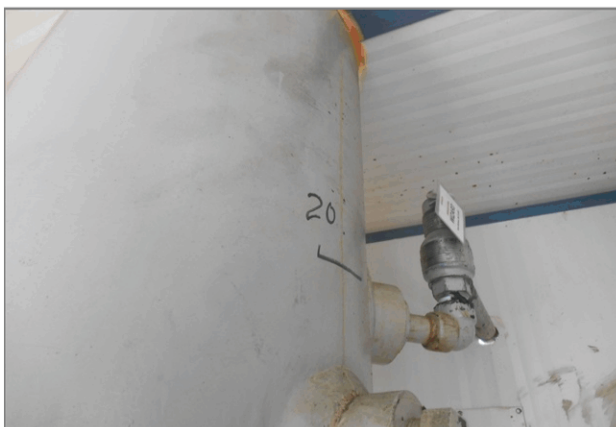
PSV STATIC DATA										
Tag #	Serial No.	Location	Size(mm)		Set Press (kPa)	Capacity Imperial (SCFM)	Manufacturer	Model	Last Service	Service Company
			Inlet	Outlet						
19697	A90337	Shell	25.40	25.40	9901	2918	Mercer	9117D51T 14E1	2013/03/26	WIZARD
