STORAGE TANK INSPECTION REPORT

LSD: 03-06-049-18W5

66177250

FIT FOR SERVICE.

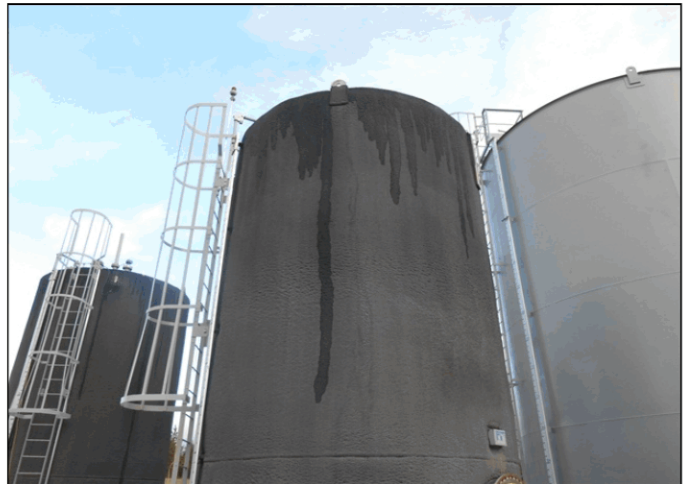
OVERALL

ID	Description	Condition	Location	NCR	Comments
T1	General Other (Please Explain)	Accept			TANK IS IN GOOD GENERAL CONDITION.
T2	General Corrosion	Accept			NO VISIBLE EXTERNAL CORROSION.
T3	General Leaks	Accept			NO VISIBLE LEAKAGES AT TIME OF INSPECTION. HOWEVER, TANK IS NOT CURRENTLY IN SERVICE.
T4	Vibration	N/A			
T5	Dissimilar Flange Rating	N/A			
T6	Ladder/Stairway	Accept			APPEARS TO BE IN GOOD CONDITION.
T7	Platform	N/A			
T8	Electrical Ground	N/A			
T9	Cathodic Protection	N/A			
T10	Painted Inactive Corrosion	N/A			
T11	Coating/Painting	N/A			
T12	Level Gauge	N/A			
T13	Bottom	N/A			
T14	Secondary Containment	N/A			
T15	Shell	Accept			APPEARS TO BE IN GOOD CONDITION. TANK IS EXTERNALLY INSULATED.
T16	Roof	N/A			
T17	Agitator/Mixer	N/A			
T18	Jacket	N/A			
T31	Support Other (Please explain)	N/A			
T32	Foundation	Accept			APPEARS TO BE IN GOOD CONDITION.
T33	Anchor Bolts	N/A			
T34	Windgirders	N/A			
T41	Connections Other (Please explain)	N/A
