PRESSURE VESSEL & COLUMN INSPECTION REPORT

LSD: 06-08-050-18W5 **Date:** 2014-03-11 **SAP Equipment ID** 66145833

VESSEL STATIC DATA										
Plant: ANSELL			OP Unit:			System:				
Prov. Insp . #: 0584723			CRN: P7217.2			Equip Tag#: 66145833				
Equipment Description: SEPARATOR						Serial #: 11377				
Manufacturer: RJV Gas Field Services						Vessel Class: vessel				
Internal Access: No			Description:			Year Built: 2008				
MAWP: 10204 kpa			At Temp 38 C			MDMT: -29 C				
Code:			RT: RT2			PWHT: No				
Diameter: 406 mm		Length: 2286 mm		(T/T): mm		OAL: mm		Orientation: Vertical		
SHELL		Mat'l: SA-106 B		Thickness: 21.41 mm		Corr Allowance: 1.59 mm				
HEAD		Mat'l: SA-516 70		Thickness: 20.60 mm		Corr Allowance: 1.59 mm				
Nozzle		Mat'l:		Thickness:		Corr Allowance:				
Internal Coating:				Internal Clad:				Capacity: m3		
Manway: No				Inspection Port: Yes				Skirt X Legs Saddle		
Nozzle Rating: lb ANSI				Painted: Yes				Insulated: No		
PROCESS DATA										
Production Description:				Sweet Sour:						
Operating Pressure kpa				Operating Temp: C

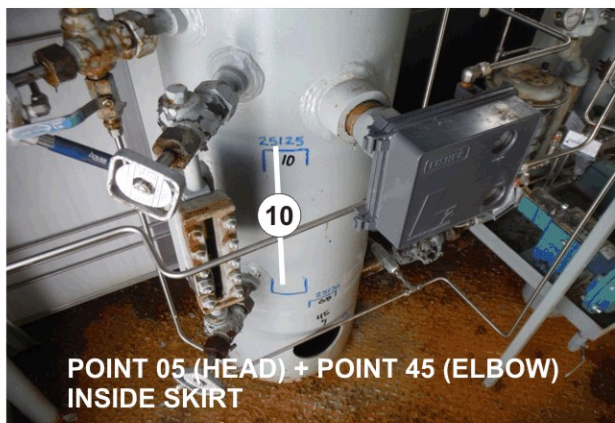
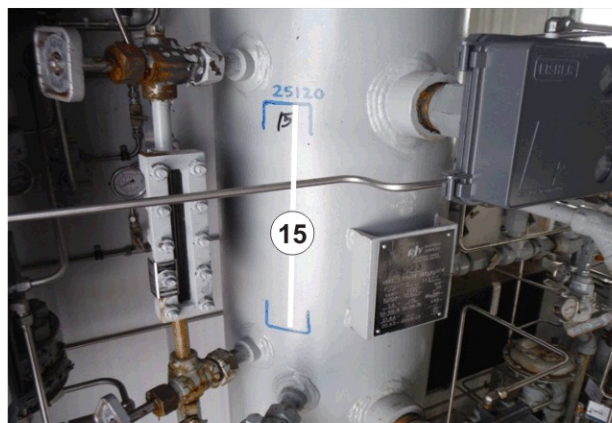
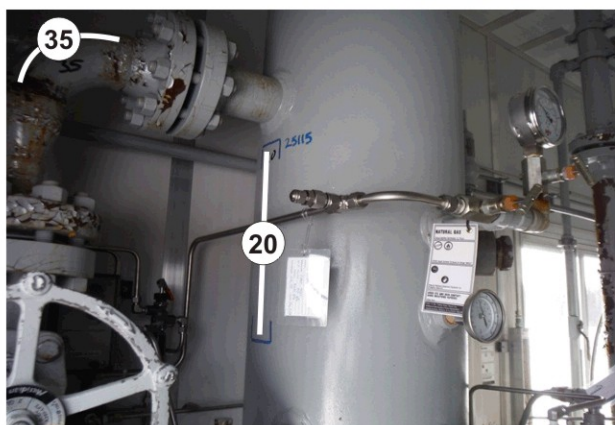
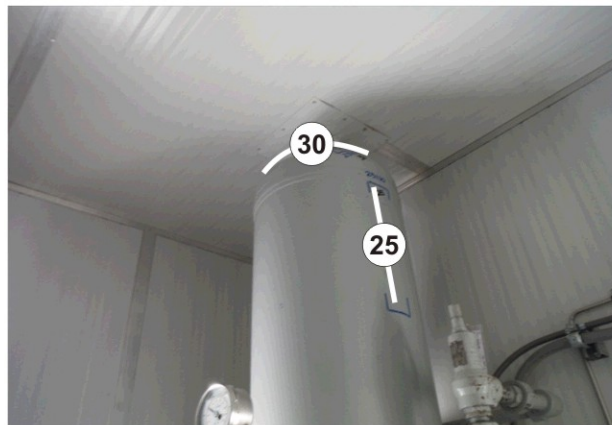
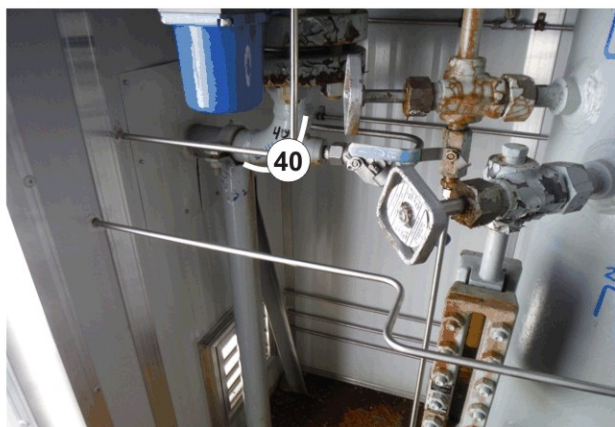
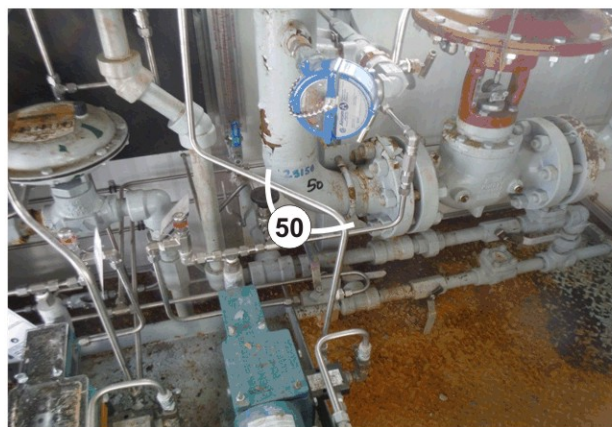
EXAMINATION ILLUSTRATION

CML	Nom. Thickness (mm)	CURRENT READINGS (mm)	short term corr rate (mm/y)	long term corr rate (mm/y)	remaining life (year)	Survey Date	Comments
05 (HEAD)	20.60	21.87	0.0000	0.0000	198.0	2014/03/11	
10 (SHELL)	21.41	22.86	0.0000	0.0000	198.0	2014/03/11	
15 (SHELL)	21.41	22.12	0.0000	0.0000	198.0	2014/03/11	
20 (SHELL)	21.41	22.50	0.0000	0.0000	198.0	2014/03/11	
25 (SHELL)	21.41	22.28	0.0000	0.0000	198.0	2014/03/11	
30 (HEAD)	20.60	21.59	0.0000	0.0000	198.0	2014/03/11	
35 (90L 3 STD)	5.49	5.03	0.0713	0.0713	24.4	2014/03/11	
40 (90L 2 160)	8.74	8.03	0.1108	0.1108	52.3	2014/03/11	
45 (90L 2 160)	8.74	8.38	0.0554	0.0554	111.0	2014/03/11	
50 (90L 3 XS)	7.62	7.82	0.0000	0.0000	198.0	2014/03/11
