Storage Tank External Visual Inspection Report

Plant: Lloydminster Production

Equipment ID: 66221239

Description:	TANK, UNIVERSAL 160M3
--------------	-----------------------

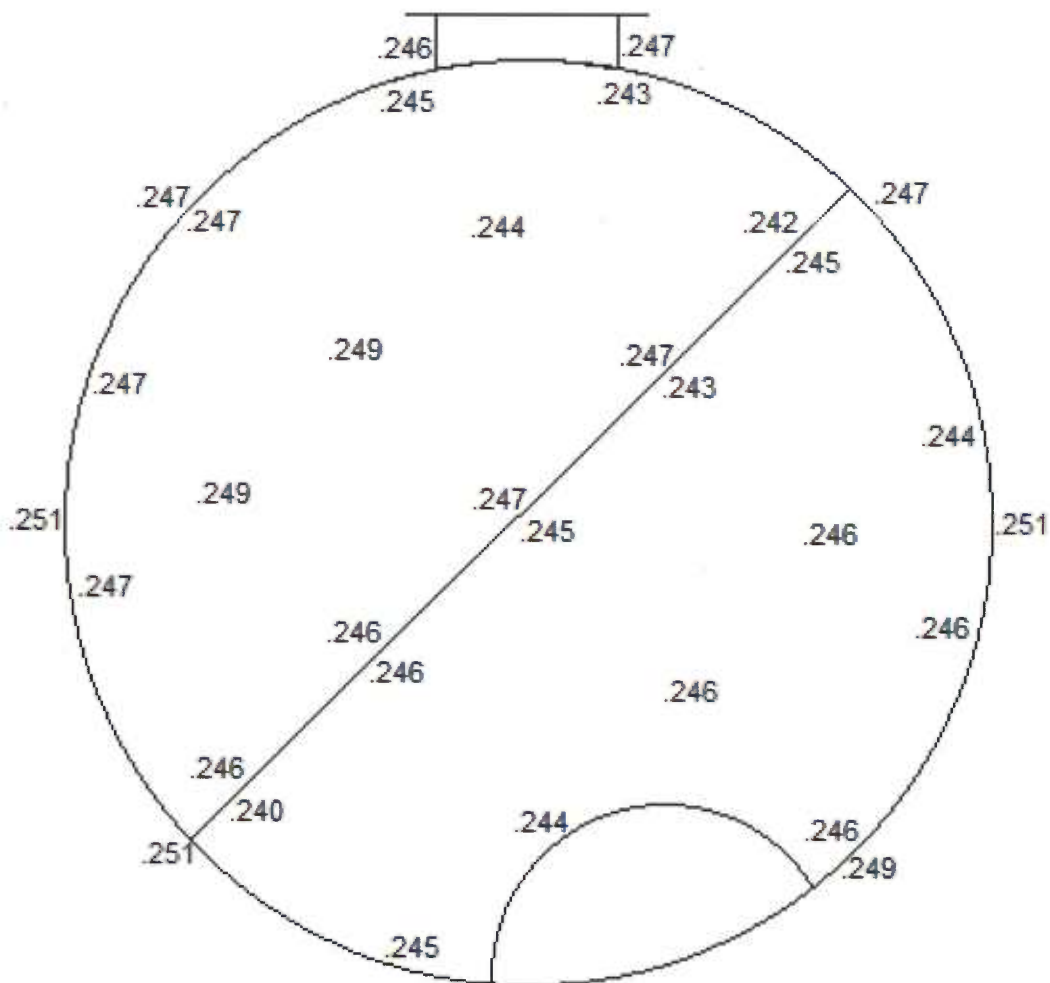
LOCATION 11-11-47-5W4 DATE 2015-11-23 MFG UIL
YEAR 2013 S/N 29085-1 CAP 1000 BBL AFE/CC 80043619
FLOOR THK 1/4" SHELL THK 1/4" 3/16" ROOF THK 3/16"
SAP # 66221239

Random locations of the tank's floor and lower shell were UT thickness tested with some minor metal loss identified. The lowest thickness identified was found to be 0.241". See attached sketch for thicknesses found and approximate locations of tests.

Continue the UT thickness survey on the tank floor and lower shell at next scheduled inspection.
