Storage Tank External Visual Inspection Report

Plant: Lloydminster Production

System: 00002 MORGAN 10-34-051-04W4 TREAT

Description:	TANK, GLM 120M3 STORAGE
--------------	-------------------------

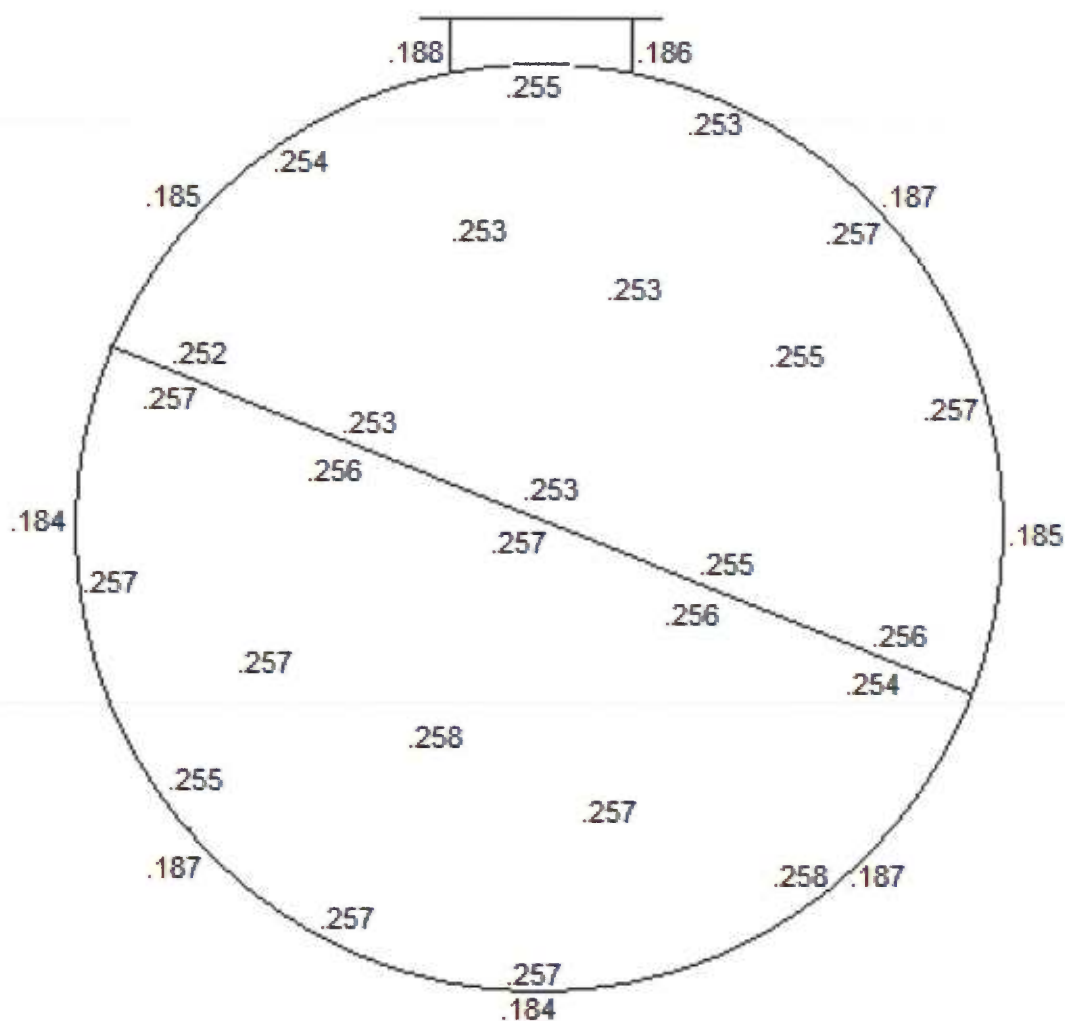
Generally the internal surfaces and components of the tank appeared to be in fair condition and suitable for continued service. It should be noted that this tank although being built in 2008 has never been in service. The internal 1" heating coil and supports were found to be in fair to good condition. Random locations of the tank's floor and lower shell were UT thickness tested with some minor metal loss identified. The lowest thickness identified was found to be 0.184". See attached sketch for thicknesses found and approximate locations of tests.

LOCATION Morgan Battery DATE 2014-12-16 MFG GLM
YEAR 2008 S/N 08-291-11 CAP 750 BBL AFE/CC 80028615
FLOOR THK 1/4" SHELL THK. 3/16" ROOF THK. 3/16"
SAP # 1000008064

Continue the UT thickness survey on the tank floor and lower shell at next scheduled inspection.
